**Performance of Home of Flood Resiliency and  
Flood Retrofit Measures**

Report No.: NRC-OCRE-2025-TRQ-005

Revision 1.4  
Date: 2025-03-28

Authors: Louis Poirier, Jacob Stolle, and Paul Knox

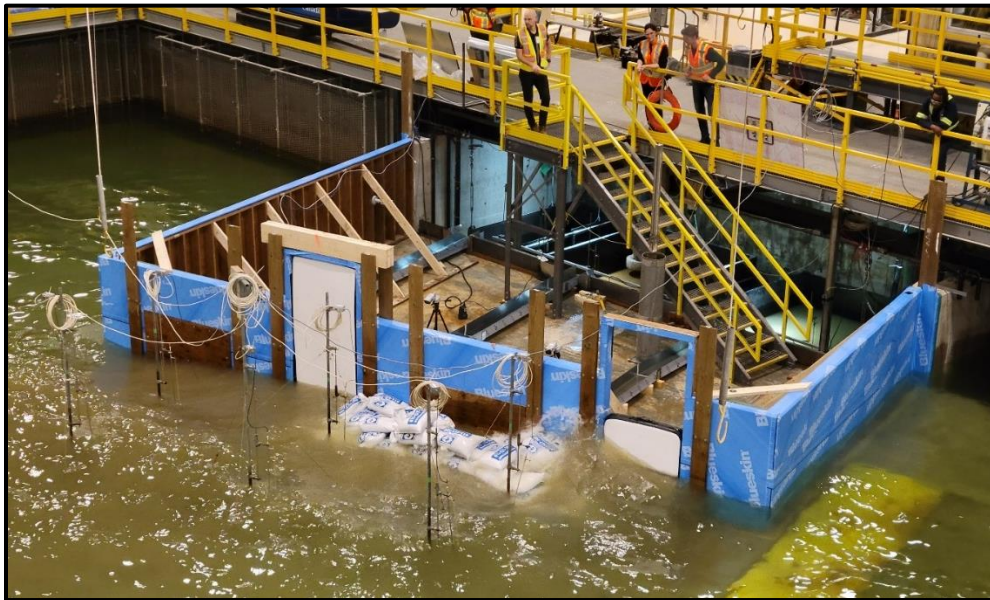
Figure 1. Phase 2 wave tests of four opening flood barriers in the National Research Council's (NRC) Multidirectional Wave Basin (MWB). From left to right: plywood, Flow Stop full sized cushion (Mono), sandbags and Flow Stop regular cushion (Bi).

- Phase 1: focused on assessing performance (leakage rates) through standard Canadian residential construction.
- Phase 2: evaluated the performance of various temporary opening flood barriers in two experimental setups (Figure 1)

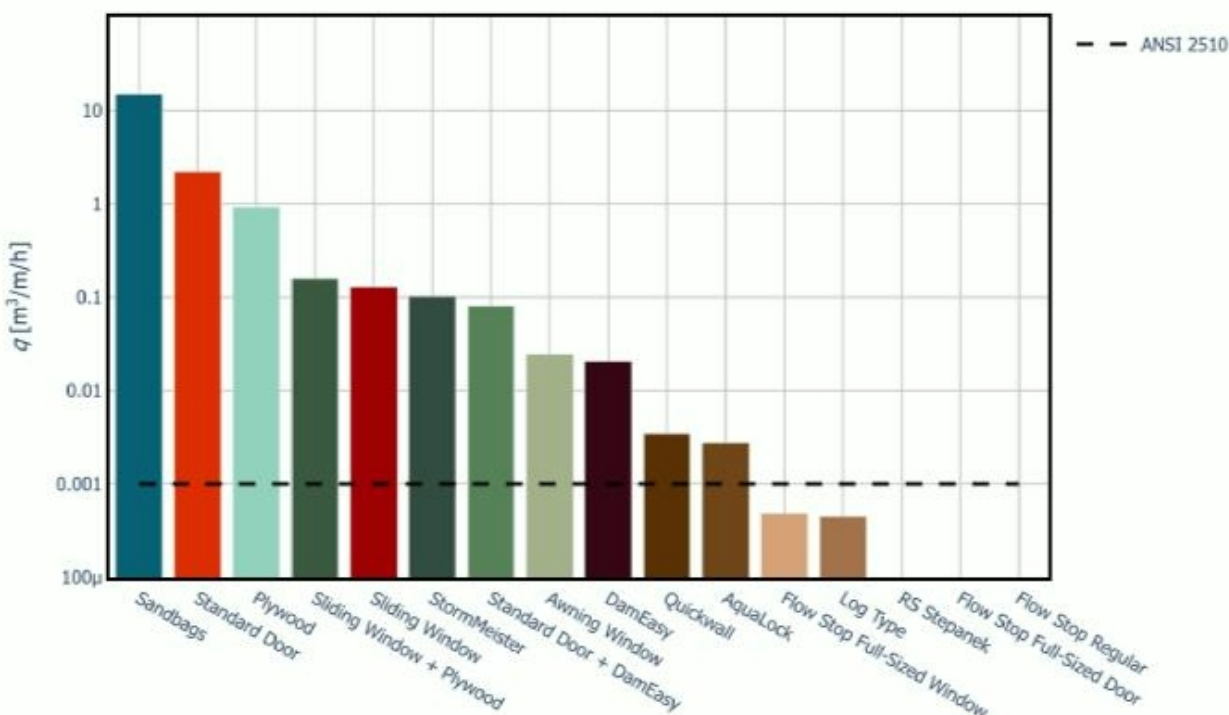
Figure 2. Summary of opening barrier performance in Phase 2 experiments at water level (0.585 m). Leakage rates are presented as volume flows per unit meter, and the ANSI 2510 threshold for opening barriers is represented by a dashed black line.

1. Barrier performance (Figure 2) :
  - a. Proprietary barriers outperformed traditional measures (sandbags, plywood).
  - b. Leakage rates for most barriers exceeded the levels suggested by ANSI 2510, particularly at greater water depths.

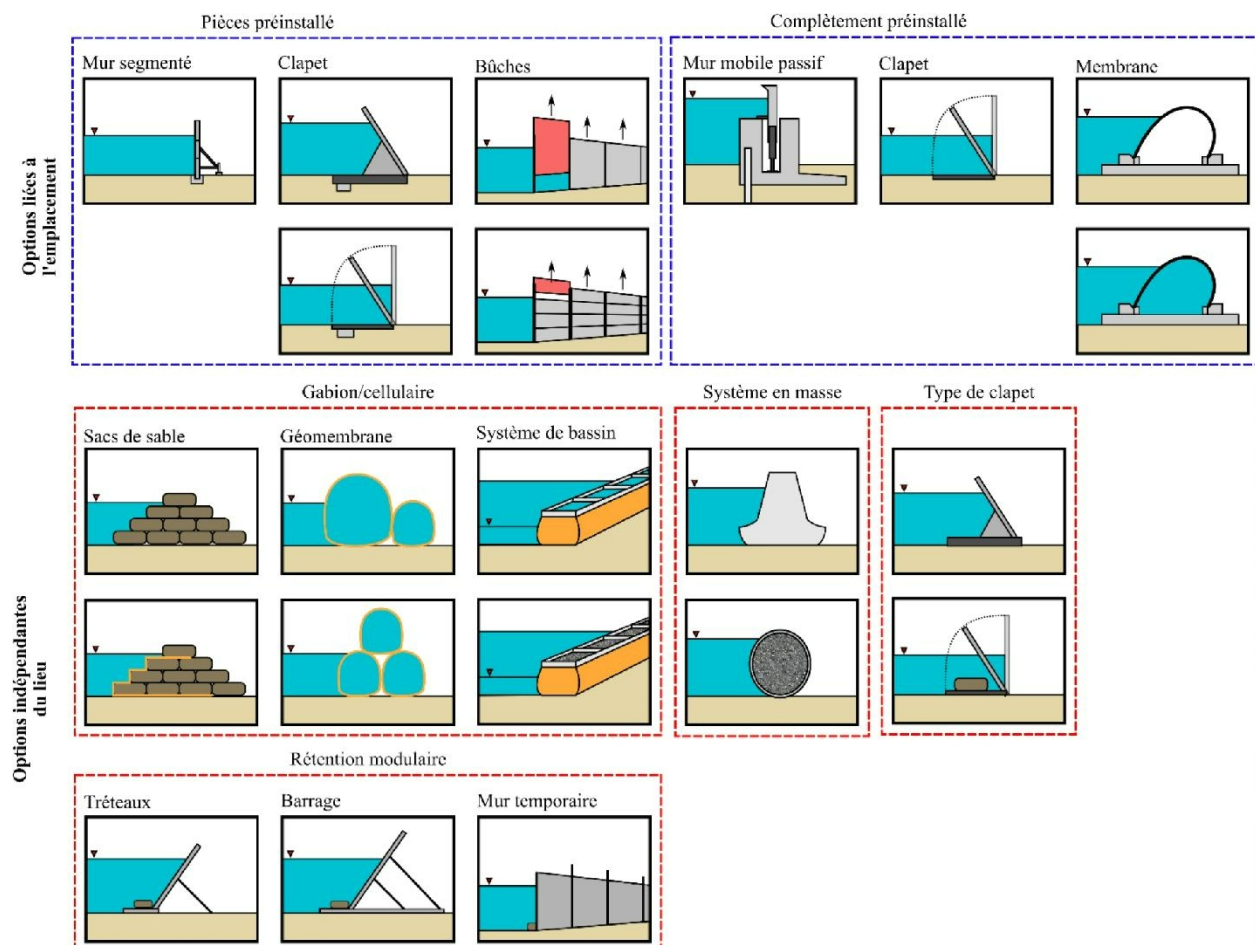
Figure 3. Classification system of perimeter barriers adapted from Massolle et al. (2018) and Biggar & Masala (1998)

Massolle et al. (2018) used a similar classification system, but more broadly classifying them based on the level of pre-installation required for the system (Figure 3). They were also able to include more recent technologies like mobile walls that respond passively to rising water levels and permanently installed membrane structures.

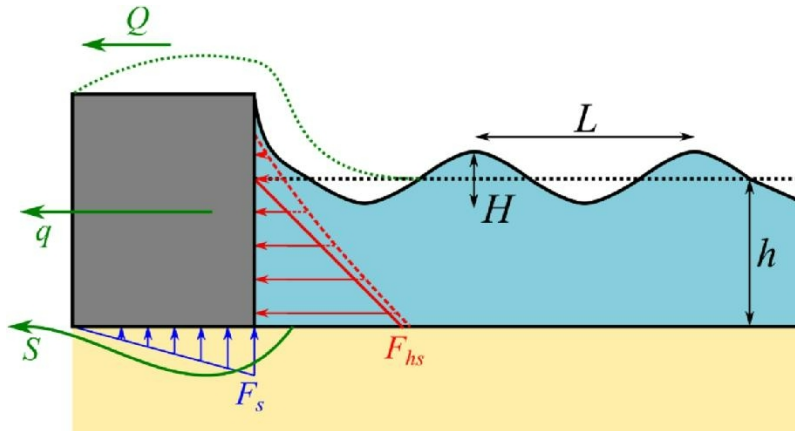
Figure 4. Forces on a flood barrier.  $H$  is the wave height,  $h$  is the water depth,  $L$  is the wavelength,  $F_{hs}$  is the hydrostatic force,  $F_s$  is the lift force,  $Q$  is the overtopping rate,  $q$  is the leakage rate, and  $S$  is the seepage rate.

can generally come from three places: over the top of the barrier (overtopping,  $Q$ ), through the barrier (leakage,  $q$ ), or under the barrier (seepage,  $S$ ). In the design standards (discussed below), the focus is often on the leakage rate through the barrier as the other two conditions are dependent on the relative overtopping level (often a design scenario that is avoided) and subsurface conditions (site-specific).

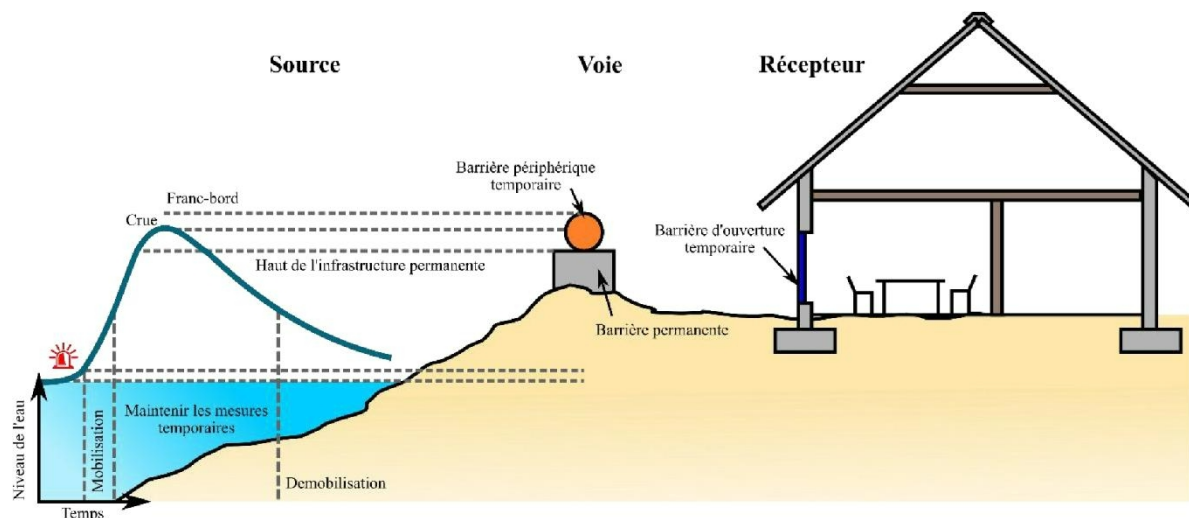
Figure 5. Source-Pathway-Receptor diagram for temporary flood barriers (adapted from Ogunyoye et al. (2011) and Bramley & Bowker (2002)).

In most cases, temporary flood systems are last line of defence in the event of a major flood event (Figure 5). They should not be relied upon for regular protection measure but should only be considered during extreme events where flooding will overtop permanent protection systems (Bramley & Bowker, 2002). The selection of the type of barrier needs to consider not only engineering considerations but also land use, cost, available human resources, and expertise.

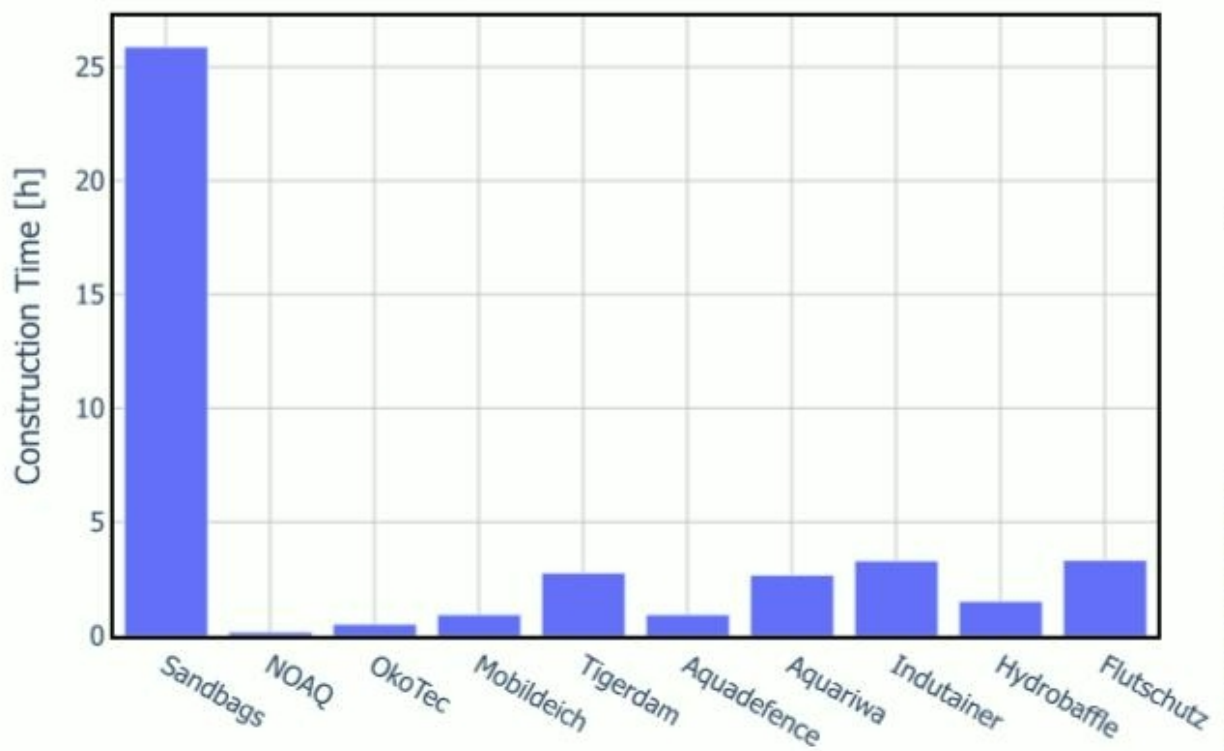
Figure 6. Construction time for 15 m of various perimeter barrier technologies (adapted from Massolle et al. (2018)).

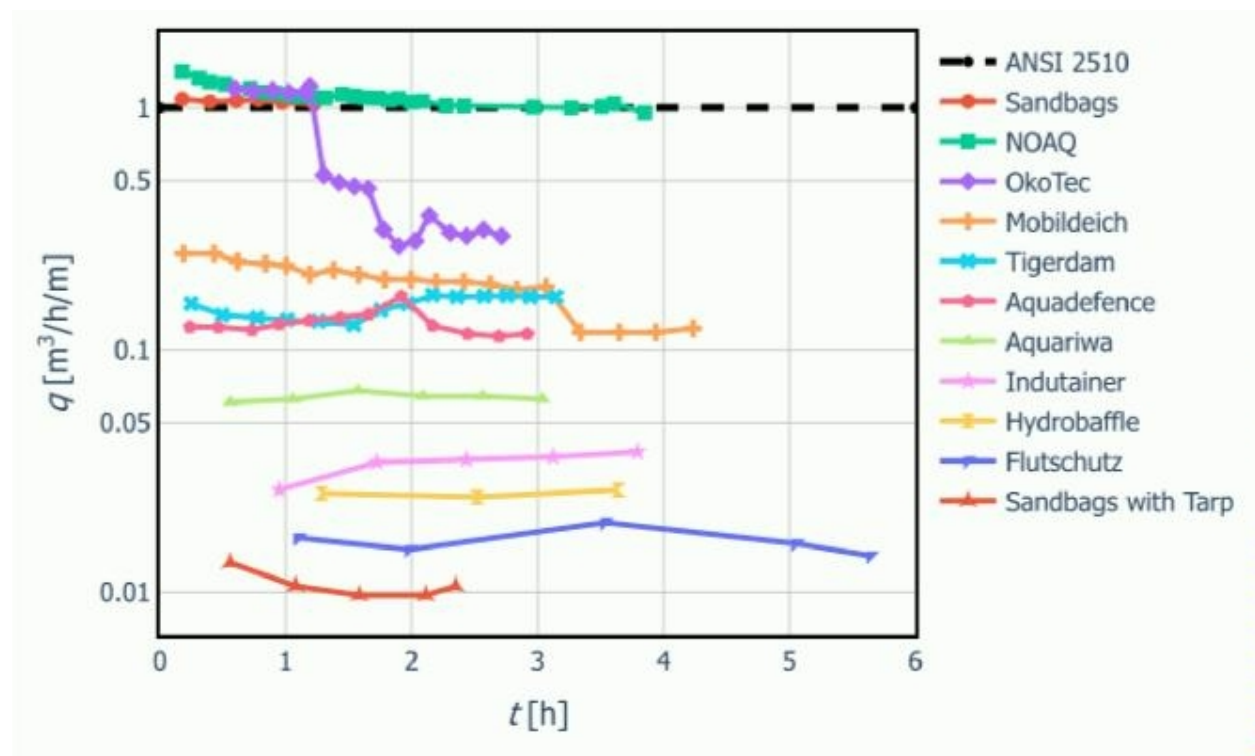
Figure 7. Combined (leakage, seepage, and overtopping) rate for various perimeter barriers (adapted from Massolle et al. (2018)) under a hydrostatic load with 0.60 m water depth.

The reported performance of SRSs in the literature is relatively minimal as they are commonly tested in the context of standards to receive certification. Massolle et al. (2018) tested a range of location-independent systems under hydrostatic loading (maximum of 0.6 m) water depth at the Institute for Hydraulic and Coastal Engineering of the Bremen University of Applied Sciences in Germany. The study examined the constructability of the systems as well as their performance, defined by the seepage value (in this case incorporating seepage, leakage, overtopping - a volume per minute per meter of structure). The study found that many of the SRS systems outperformed sandbags (Figure 7) and they were also able to be constructed much quicker. Massolle et al. (2018) noted the importance of the surface below the barrier (in this case, natural turf) on the performance of the different systems.

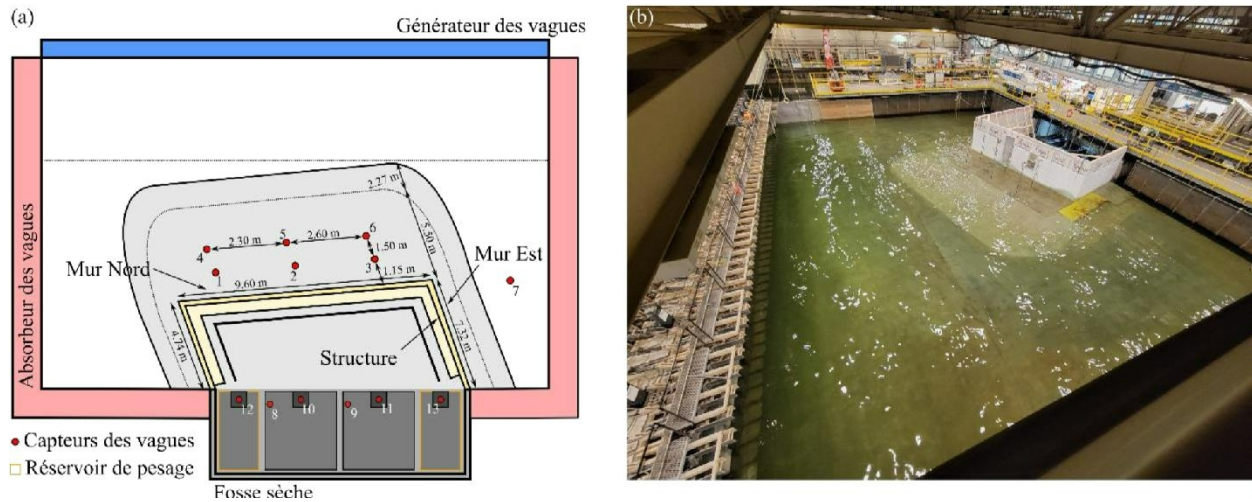
Figure 8. Plan view of the experimental facilities at the NRC. (a) Conceptual sketch of superstructure and instrument positions; (b) photo of Phase 1 testing of waves.

The experiments were performed in the multi-directional wave basin at the National Research Council of Canada (NRC) in Ottawa, Canada. The wave basin is 30 m × 36 m × 3 m with a multi-directional wave generator on one side and a dry pit on the opposite side. The building envelope (hereafter referred to as the superstructure) was placed on a raised reinforced concrete pad (0.254 m high). The platform was surrounded by a 1:8.9 slope down to a flat surface. In front of the wave generator, a slope of 1:9.66 raised the bed up 0.75 m to the flat surface. The zero-reference elevation was considered to be at the elevation of the concrete pad.

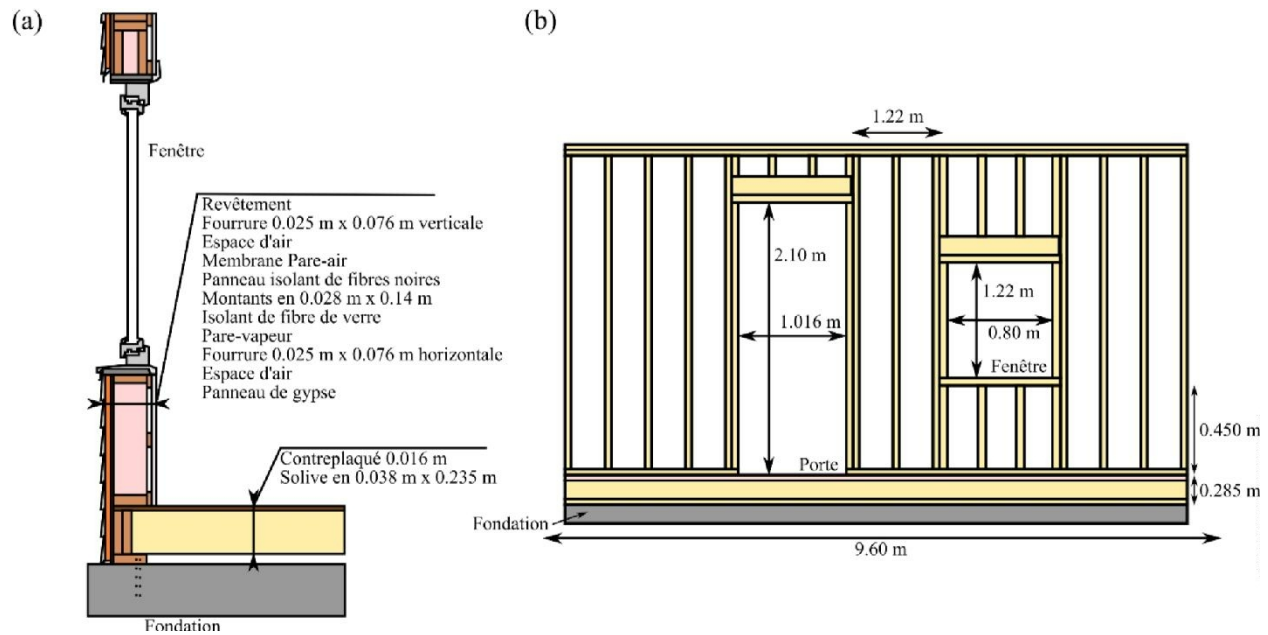
Figure 9. Phase 1 superstructure based on Ontario Building Code. (a) Cross-section of the superstructure; (b) front view of the superstructure.

The superstructure in Phase 1 was built to represent a common residential dwelling following the National Building Code of Canada 2020 (NBC, 2020). The structure was built with 0.038 m × 0.14 m kiln dried SPF lumber. The cross-section of the wall component is shown in Figure 9a. The floor joists were placed on 0.038 m × 0.14 m sill plates and attached to concrete platform with 13 mm diameter anchor screws every 1.20 m (as well as at each corner and at the openings). A rim joist (0.038 m × 0.235 m) was placed on the sill plate. Wall studs were placed at approximately 0.41 m intervals and were nailed according to the National Building Code of Canada 2020. One door opening (0.285 m above the platform) and one window opening (0.735 m above the platform) was constructed in the building envelope.

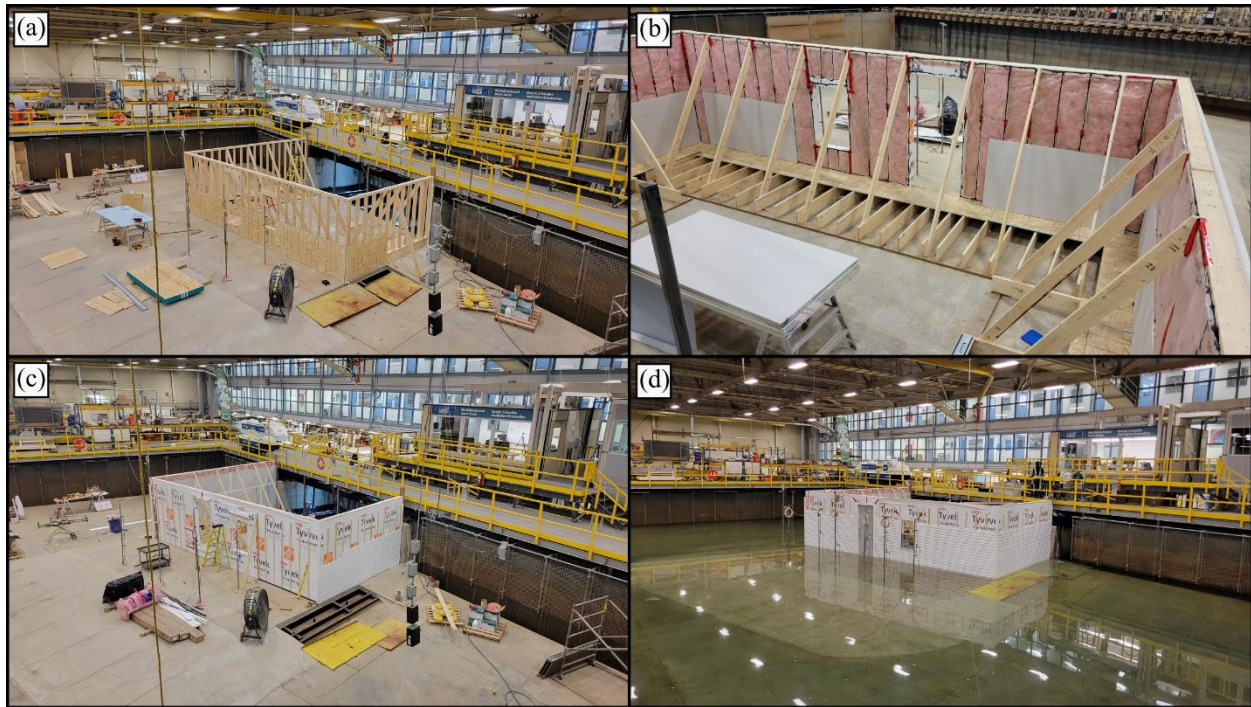
Figure 10. Construction of the Phase 1 superstructure. (a) Framing of superstructure; (b) superstructure with insulation and support structure installed; (c) superstructure with exterior cladding being installed; and (d) completed superstructure during testing.

The floor joists (0.038 m x 0.235 m) were connected to tie back plates 1.67 m behind the building envelope. Vertical braces were placed approximately every 1.20 m connecting the top plates to the tie back plates (Figure 10b) and aligned with floor joists. The vertical braces were connected to top plates with four 65 mm nails. The wood frame was covered with 11 mm plywood sheathing and the floor was covered with 16 mm plywood. The interior of the wall was constructed using the cross-section presented in Figure 9a. The exterior cladding was only placed up to a maximum height of 1.95 m (Figure 10b).

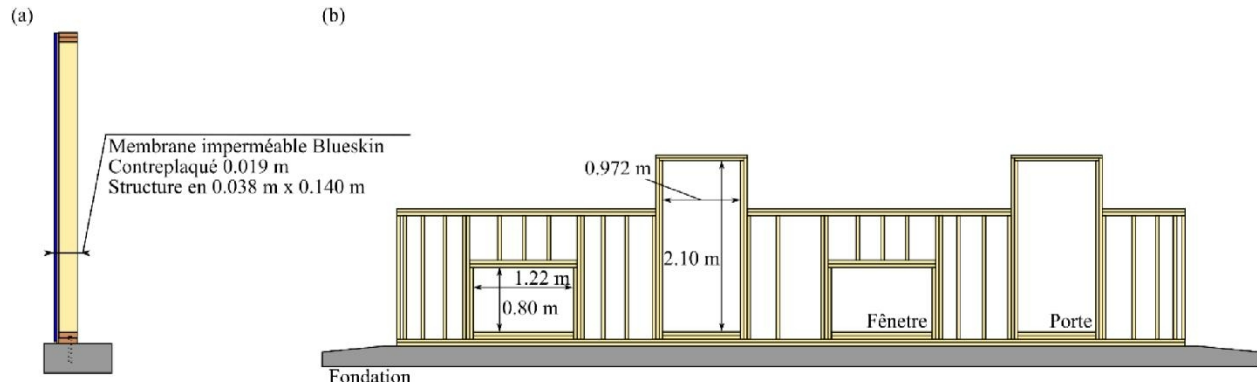
Figure 11. Conceptual drawing of Phase 2 structure. (a) Cross-section of the superstructure; (b) front view of the superstructure frame.

To avoid any influence of the superstructure on the opening barrier performance, the structure was designed and reconstructed to be rigid and impermeable to water (the residential home from Phase 1 was removed and rebuilt fit for purpose). The structure was built with 0.038 cm × 0.14 m pressure-treated wood. The cross-section of the wall component is shown in Figure 11a. The wall frame was placed on 0.038 cm × 0.14 m sill plates and attached to concrete platform with 13 mm diameter anchor screws every 0.40 m (as well as at each corner and at the openings). Wall studs were placed at approximately 0.30 m intervals and were nailed according to the National Building Code of Canada 2020.

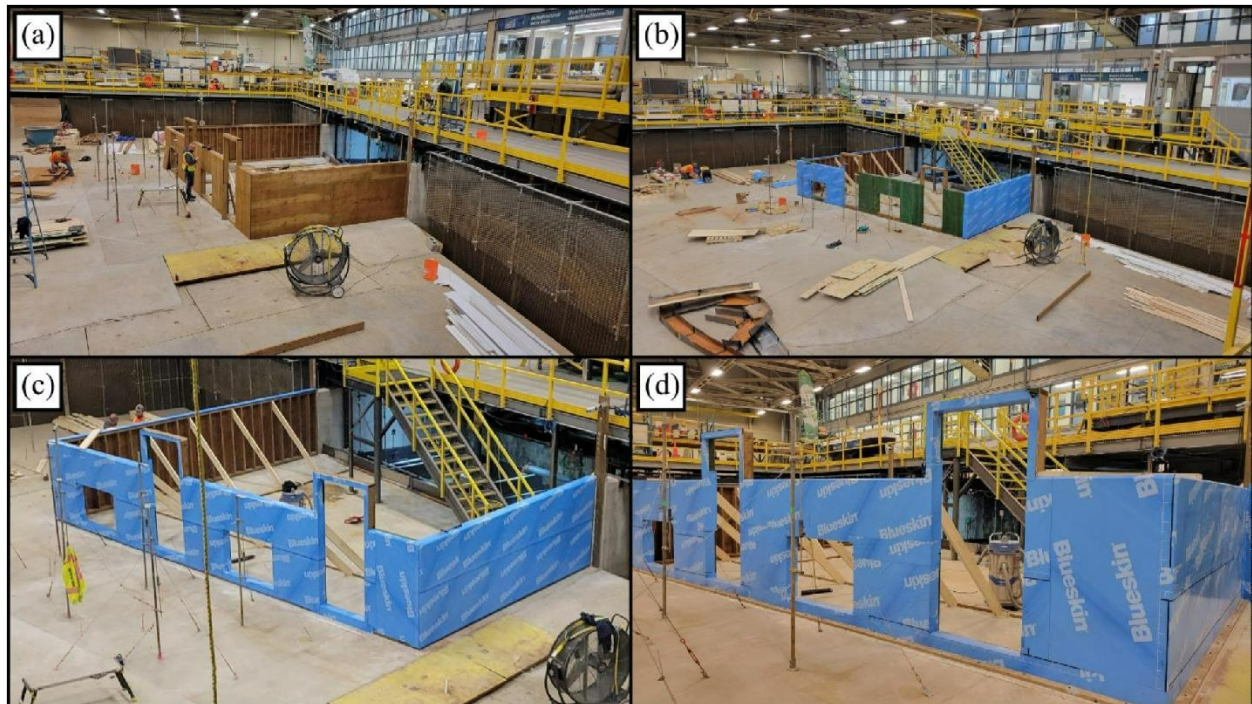
Figure 12. Construction of the Phase 2 impermeable structure. (a) Wood framing of structure; (b) placement of the waterproofing membrane; (c) completed waterproofing membrane; and (d) door and window openings.

Two door and two window openings were placed 0.15 m above the concrete platform. All the openings were at the same height above the concrete platform to ensure the barriers were exposed to the same conditions. The wood frame was enclosed with 19 mm plywood sheeting and covered with an impermeable membrane (Blueskin WP200). Figure 12 shows the evolution of the construction of the impermeable structure within the NRC MWB basin.

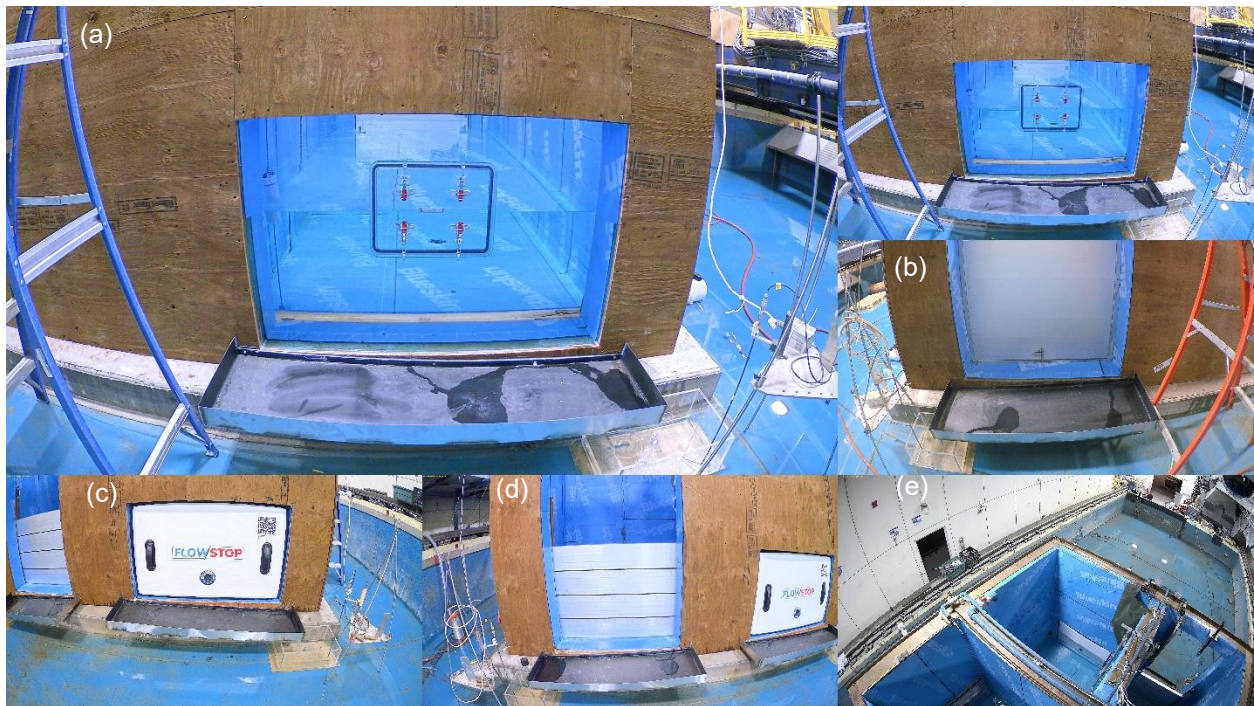
Figure 13. Images of the NRC Ottawa Ice Tank facility during Phase 2 testing

A new superstructure was built within the NRC Ottawa Ice Tank facility (IT) which had a similar design to the Multidirectional Wave Basin (MWB) Phase 2 superstructure. However, the IT superstructure was designed to hold water in the interior (the inverse of the MWB) and could support deeper water depths. The structure was built on a 0.20 m thick concrete pad with an area 4.096 m by 4.096 m. The IT superstructure itself was 3.696 m by 3.696 m with three internal reservoirs – i.e. the ability to test up to three barriers at once all to their own unique water level. Images from the testing within the facility are shown in Figure 13. One small reservoir had a window (Figure 13c), and another small reservoir had a door (Figure 13d), while the larger reservoir had both as shown in Figure 13a and Figure 13b or illustrated in Figure 14. The water level in each reservoir was maintained by an automatic valve.

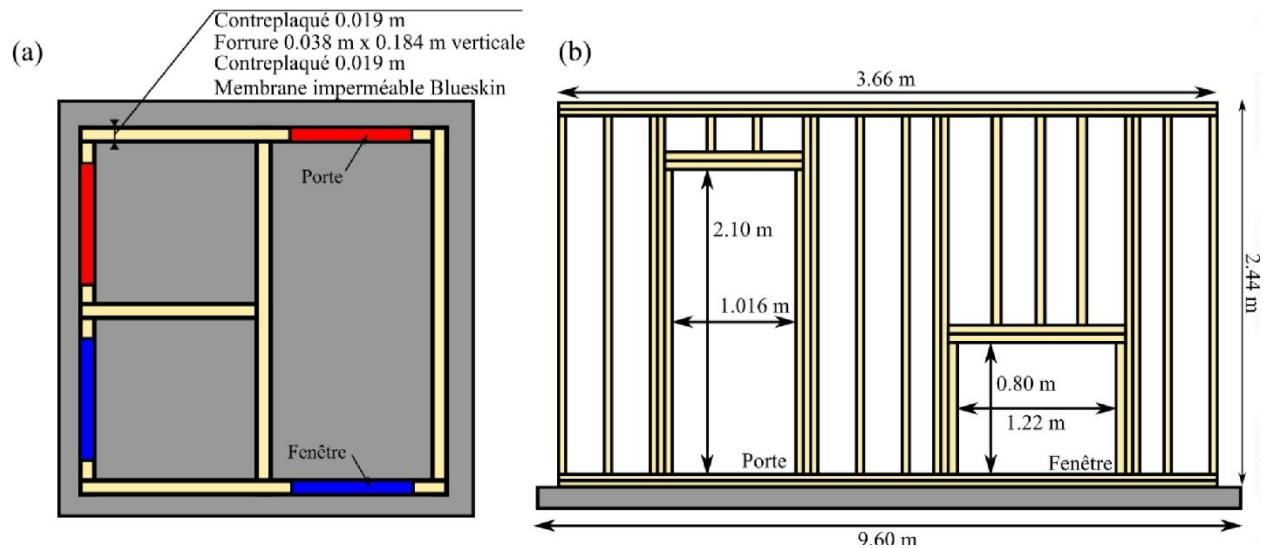
Figure 14. Conceptual drawing of Phase 2 NRC Ice Tank facility. (a) Top view of individual reservoirs (water was placed within the structure). (b) Side view of the structure (shown on the left side of top view).

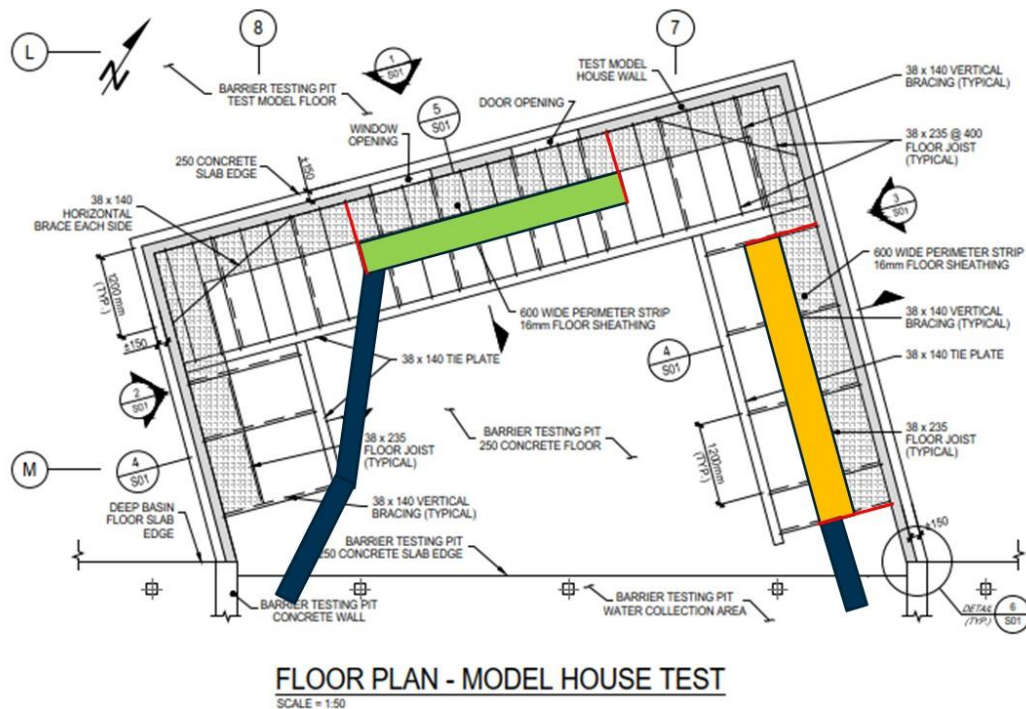
Figure 15. Catch basin system for measuring leakage rates for Phase 1. In green we have the catch basin for the door and window openings; In yellow we have the catch basin for the east wall.

The main measurement of performance was the leakage rate through either the residential home (Phase 1) or through the opening barriers (Phase 2). The leakage rate was measured using a catch basin system illustrated in Figure 15 and shown in Figure 16. In Phase 1 the leakage was collected from three locations. The first, basement leakage, was collected along the entire 21.37 m perimeter of the model home from the concrete foundation up to the floor package, 0.285 m above the foundation. The water accumulated on the floor of the model home and eventually collected within two tanks within the dry pit where it was measured as a single leakage value. The second location measured leakage through the window and door openings along the north wall and was collected in a 4.41 m long catch basin indicated in green in Figure 15. The catch basin was attached to the floor package which was installed 0.285 m above the foundation. A piece of plywood was used to connect each end of the catch basin to the wall of the model home as shown in Figure 16. The plywood piece was sealed with silicone. The third location where leakage was measured was along the east wall. The 4.51 m long catch basin is indicated in orange in Figure 15. The east wall catch basin was also attached to the floor package, 0.285 m above the foundation, and sealed to the wall with plywood. The blue sections in Figure 15 indicate the gutters running from the north and east catch basins towards two separate tanks within the dry pit. The gutters from the north catch basin are also shown in Figure 16.

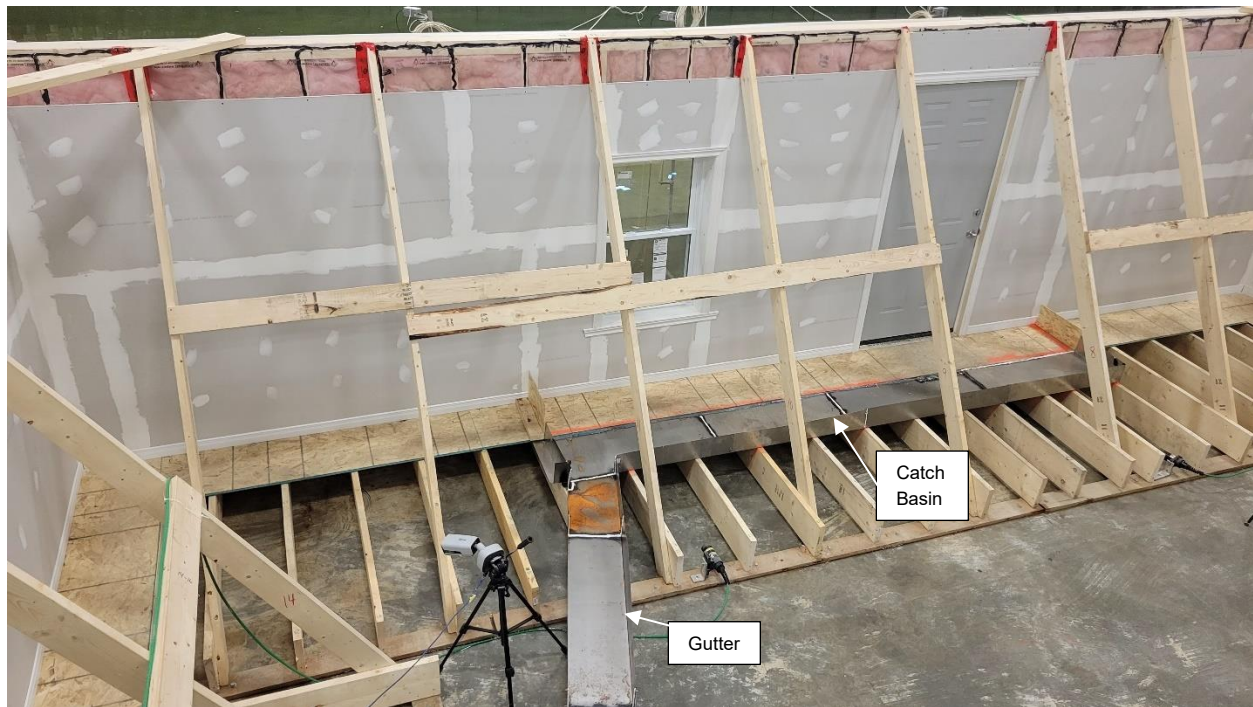
Figure 16. Catch basin system for measuring leakage rates from the door and window openings during Phase 1. A gutter leads from the catch basing towards the dry pit.

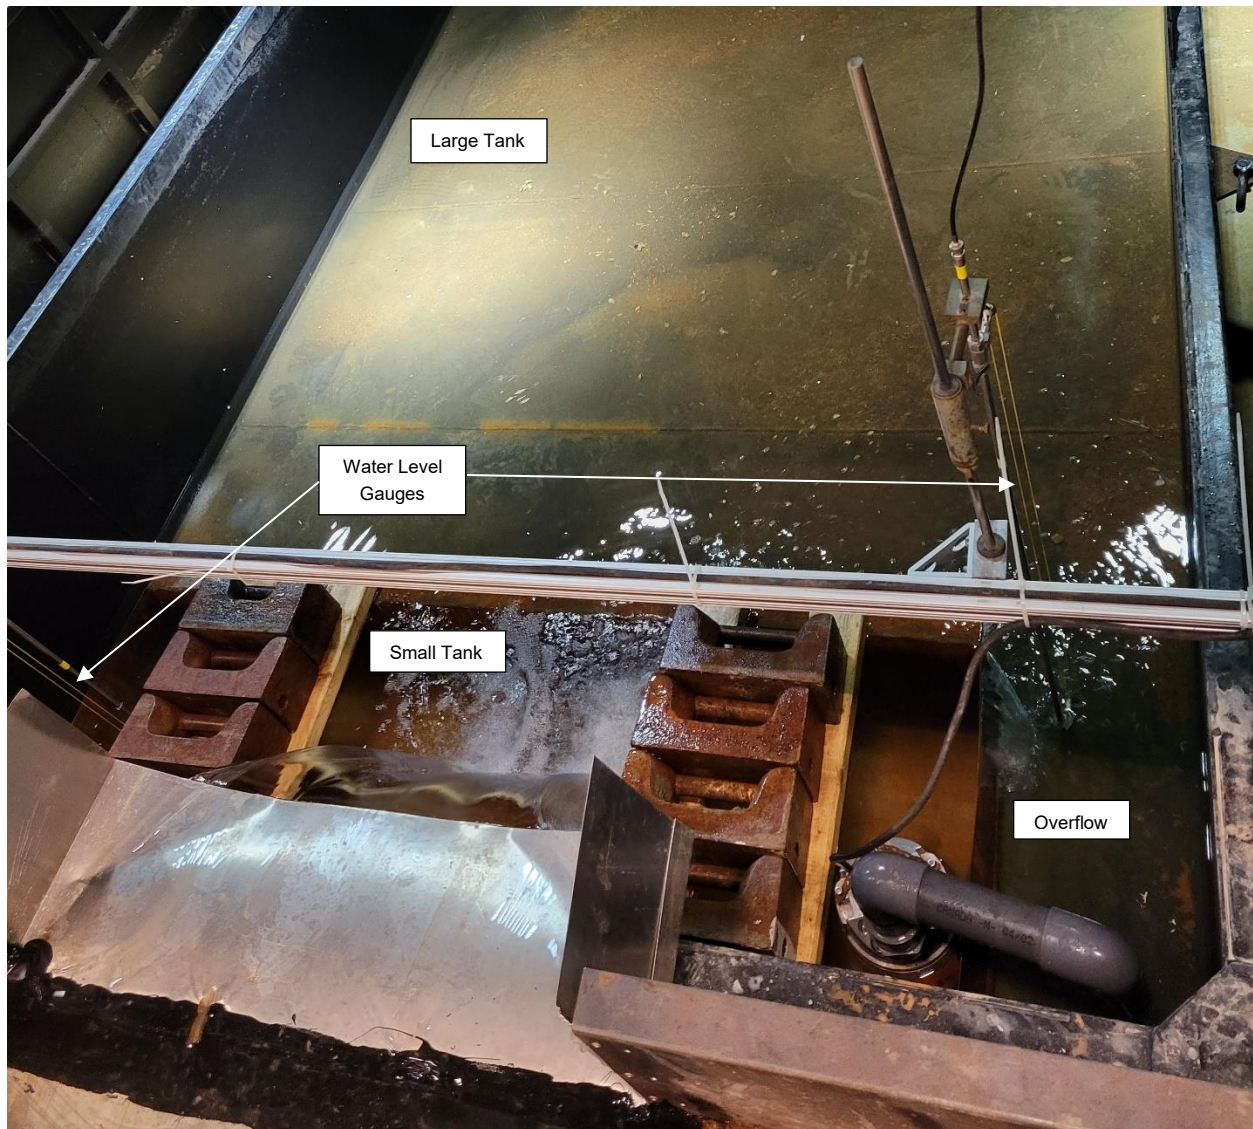
Figure 17. Leakage rate measuring tanks within the dry pit for Phase 1.

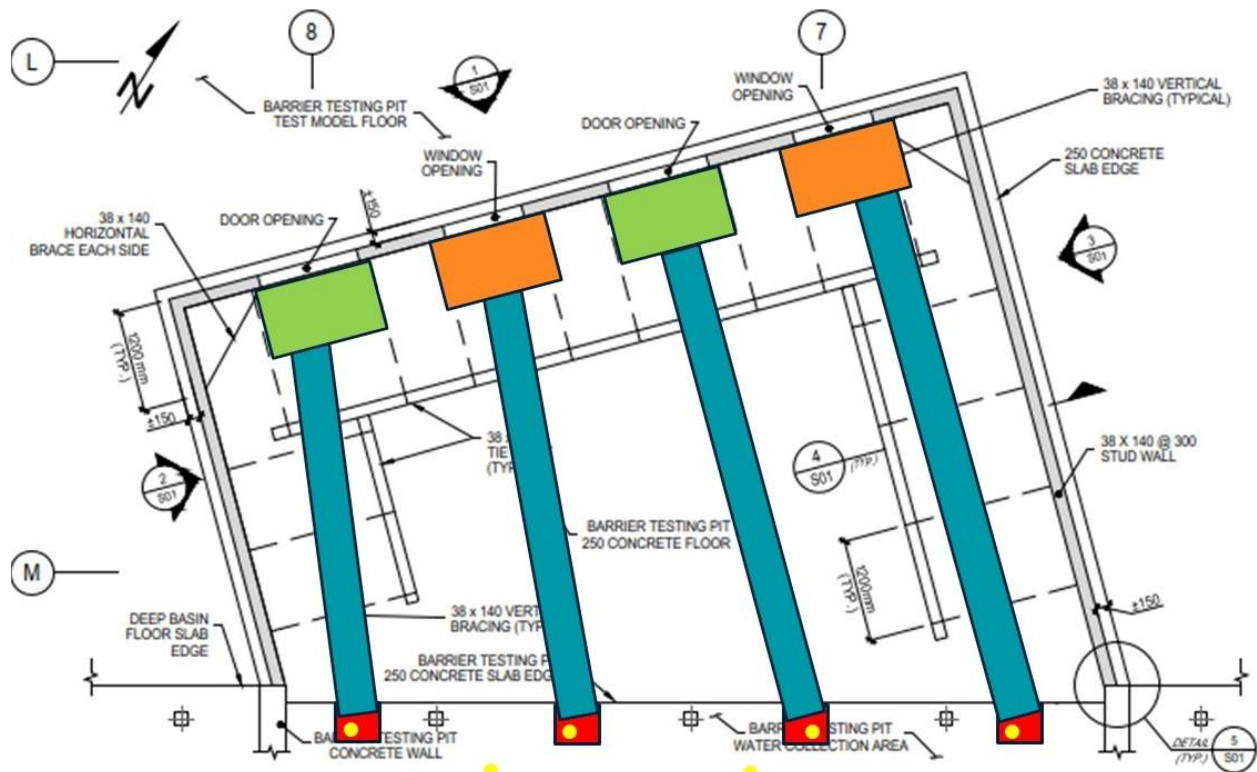
Figure 18. Catch basin system for measuring leakage rates for Phase 2. In green we have the catch basins for the two door openings, in orange we have the catch basin for the two window openings.

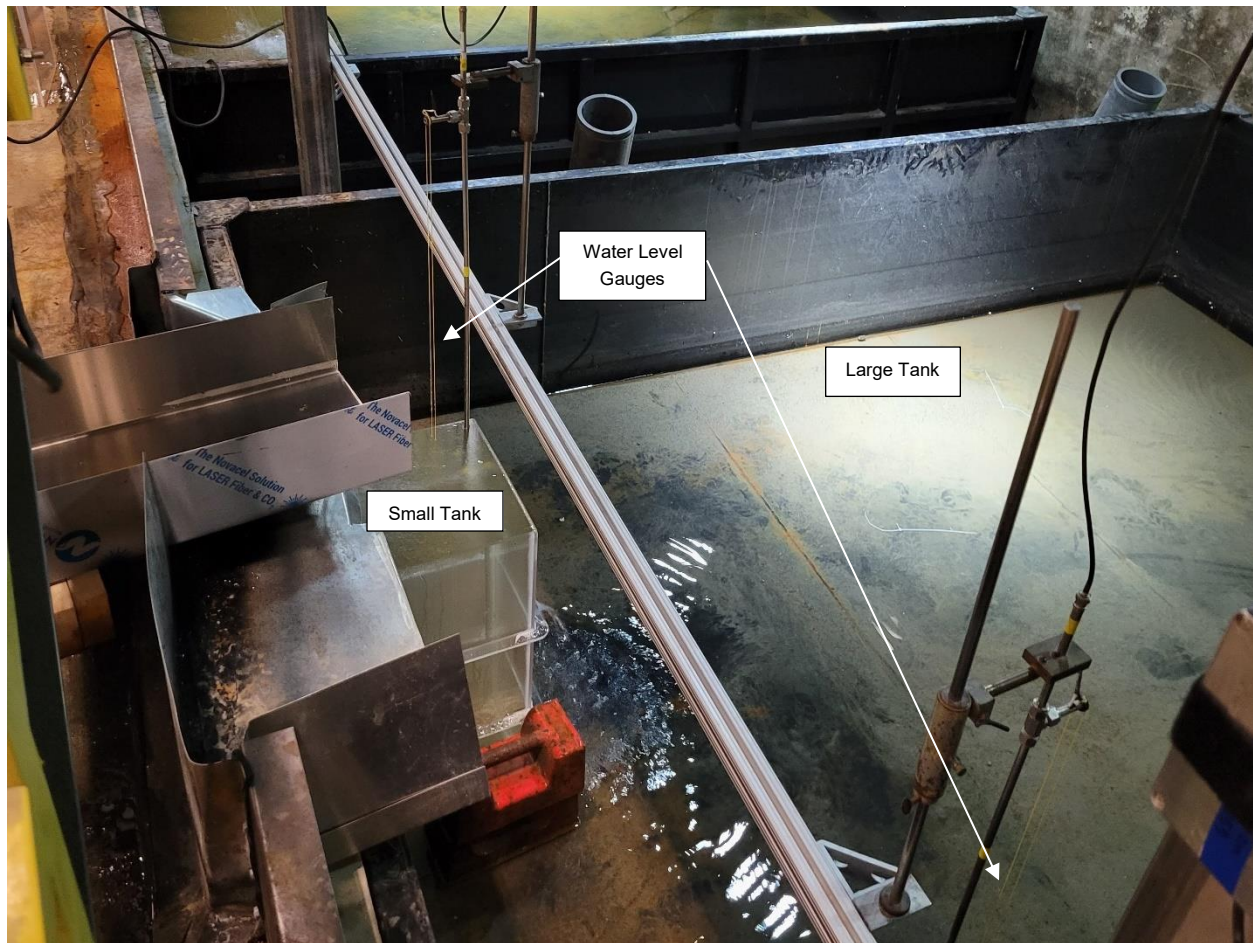
Figure 19. Leakage rate measuring tanks within the dry pit for Phase 2.

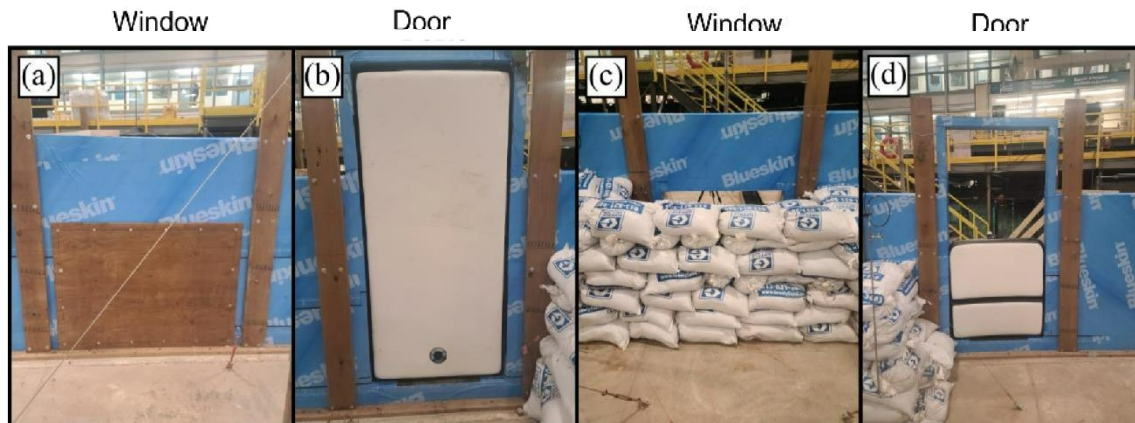
Figure 20. Opening barriers deployed in the MWB in Phase 2 – first set of tests: (a) plywood; (b) Flow Stop full-sized cushion; (c) sandbags; and (d) Flow Stop regular cushion.

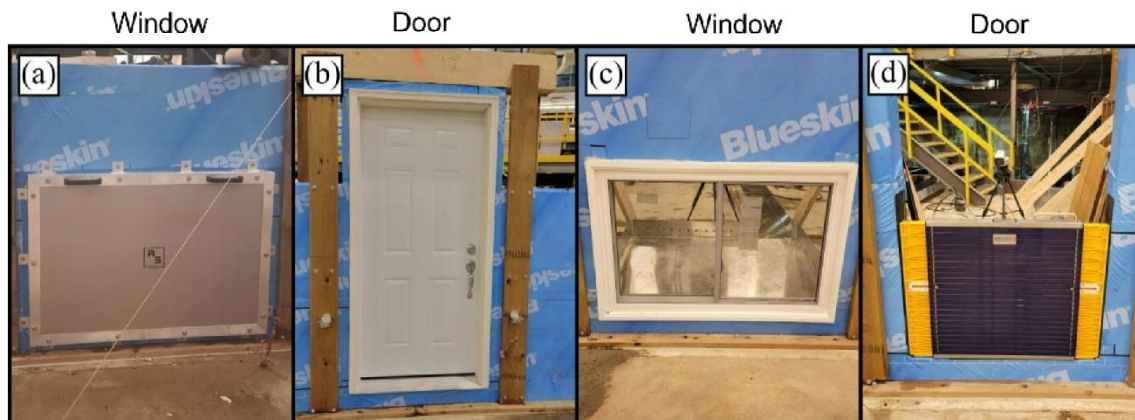
Figure 21. Opening barriers deployed in the MWB in Phase 2 – second set of tests: (a) RS Stepanek; (b) Standard Door; (c) Sliding Window; and (d) DamEasy.

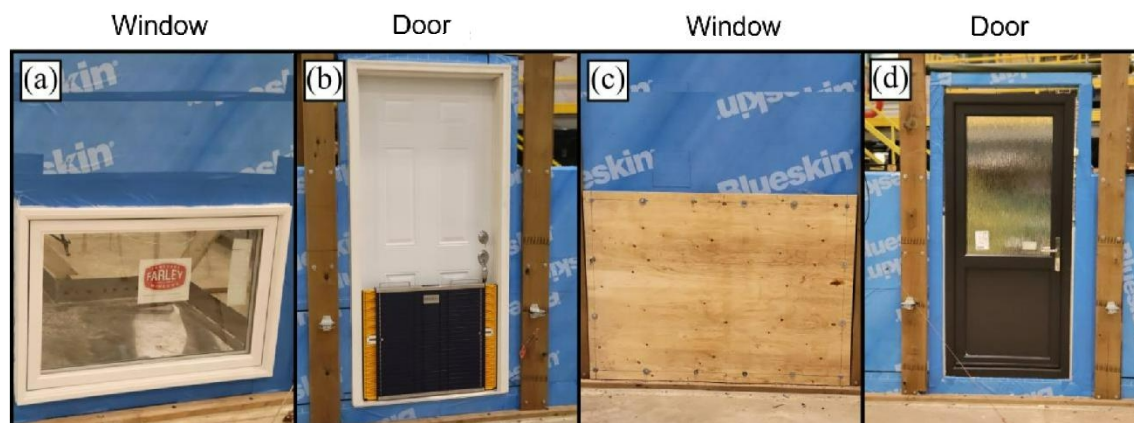
Figure 22. Opening Barriers deployed in the MWB during Phase 2 – third set of tests: (a) Awning window; (b) Standard Door with DamEasy; (c) Sliding Window with plywood; and (d) Stormmeister Flood Resistant Door.

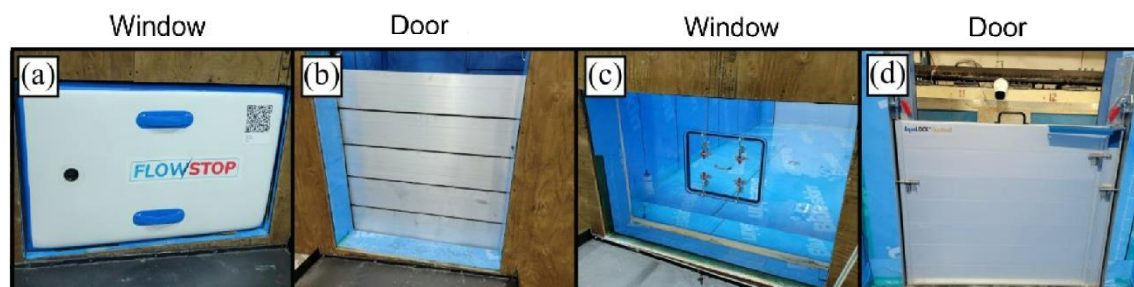
Figure 23. Opening barriers deployed in the IT in Phase 2: (a) Flow Stop full-sized cushion; (b) Stormmeister Rapid Assembly Log type Barrier; (c) Aqualock Window Protector; and (d) Aqualock Quickwall.

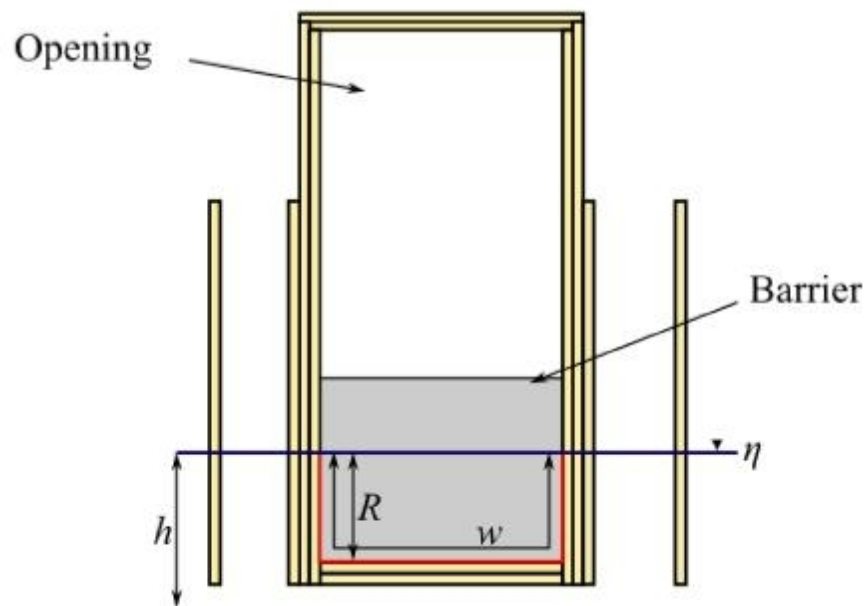
Figure 24. Important parameters for the analysis of leakage rate through the temporary barriers.
