**Performance of Home of Flood Resiliency and  
Flood Retrofit Measures**

Report No.: NRC-OCRE-2025-TRQ-005

Revision 1.4  
Date: 2025-03-28

Authors: Louis Poirier, Jacob Stolle, and Paul Knox

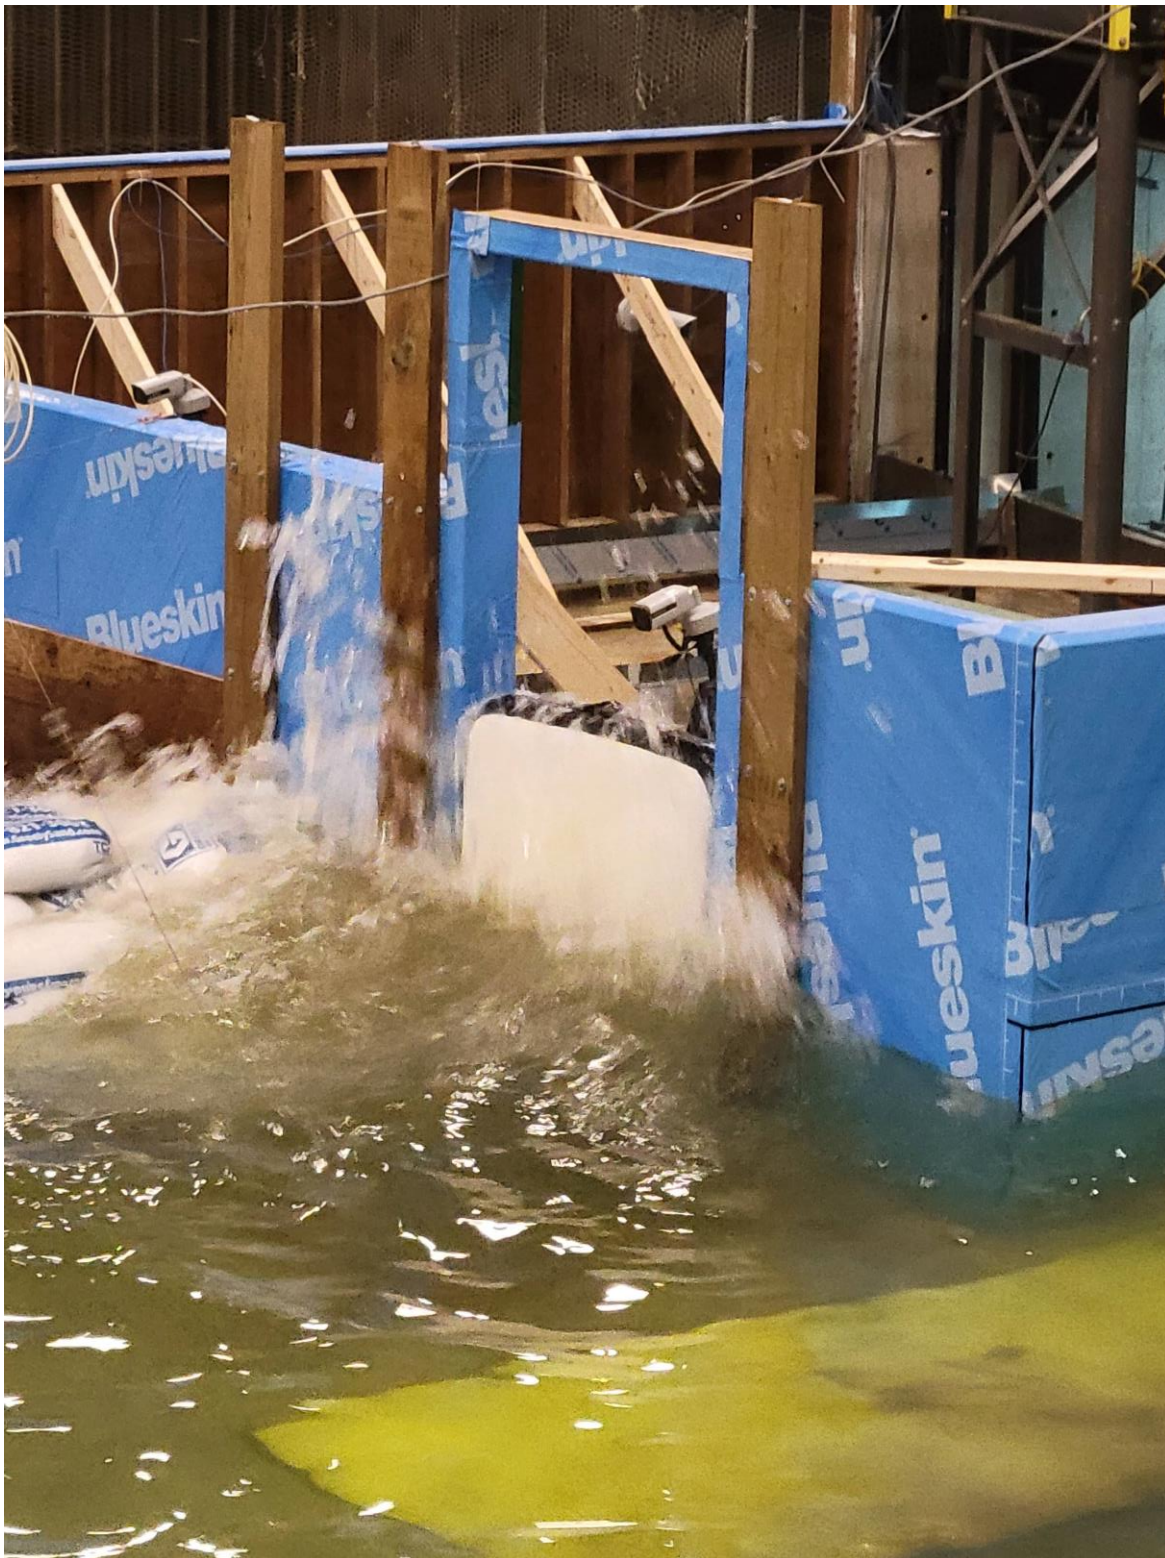
Figure 25. Image from Phase 2: TSE – west door, waves overtopping the FlowStop regular cushion.

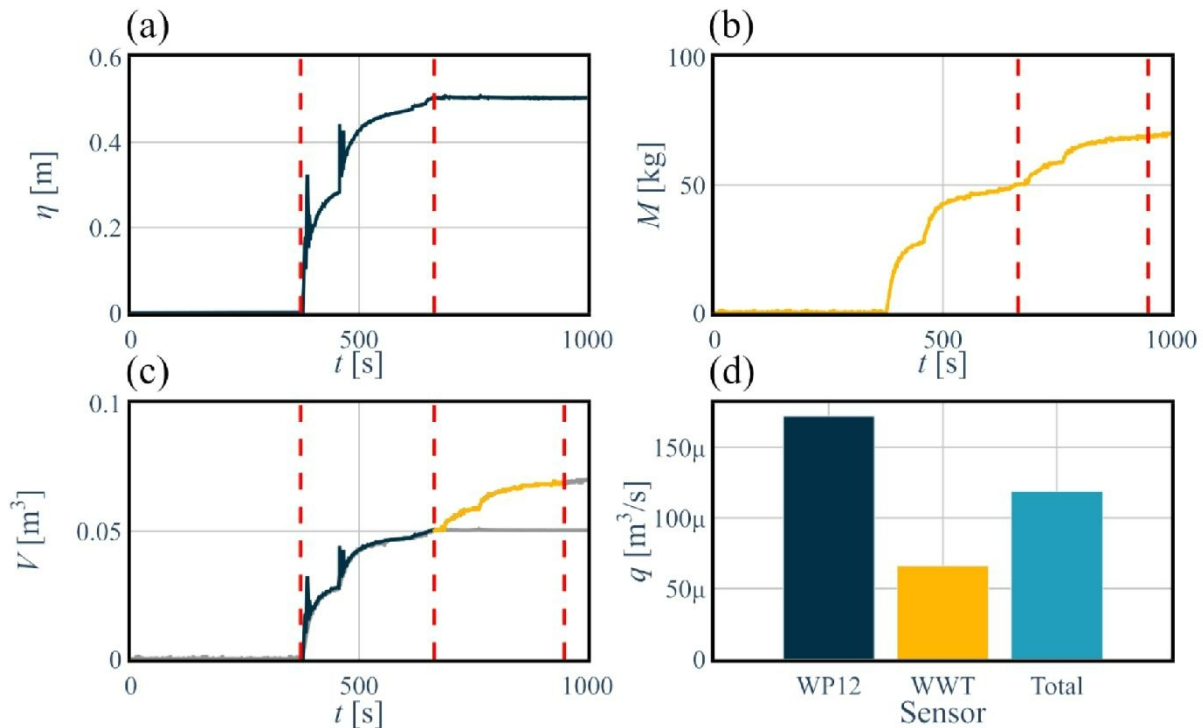
Figure 26. Measurement of overtopping rates. Example taken from Phase 2: TSE – Flow stop regular cushion on the west door opening. (a) water level measurements (WP12) in small tank; (b) weight tank measurements (WWT); (c) combined volume measurements from the two measurement methods; and (d) average overtopping rates measurements from two methods.

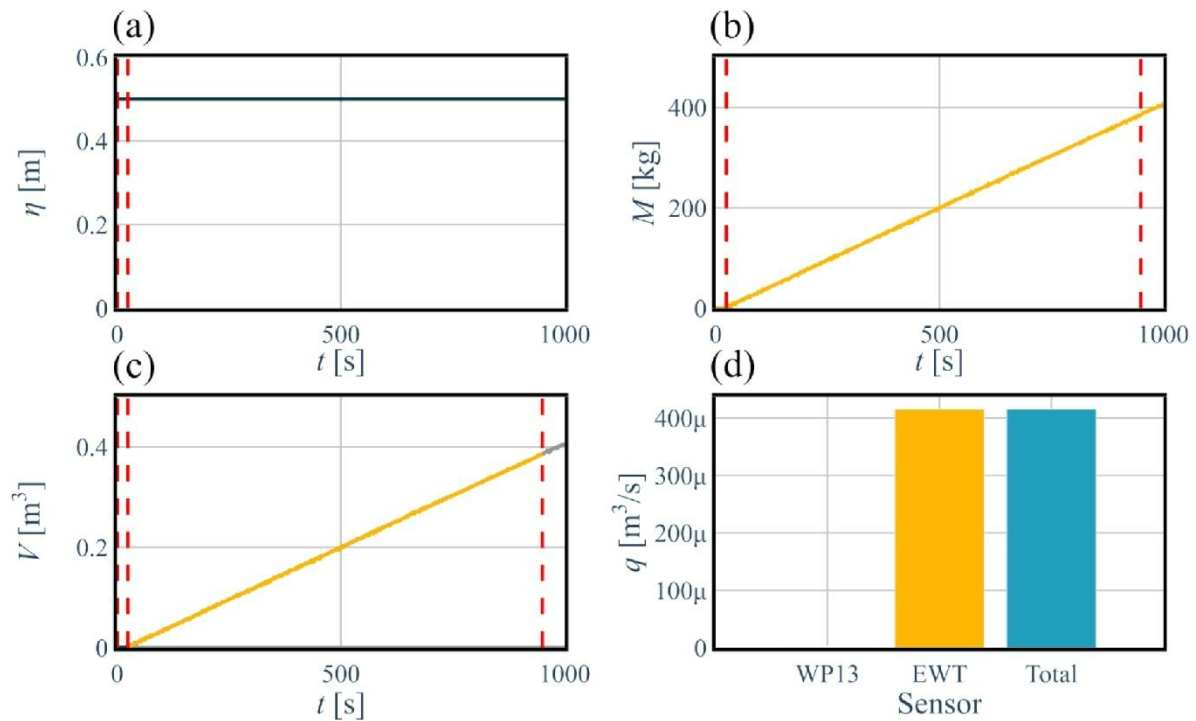
Figure 27. Leakage rates calculation taken from Phase 2: TSE – plywood board over east window opening. (a) water level measurements (WP13) in small tank; (b) weight tank measurements (EWT); (c) combined volume measurements from the two measurement methods; and (d) leakage rates measurements from two methods.

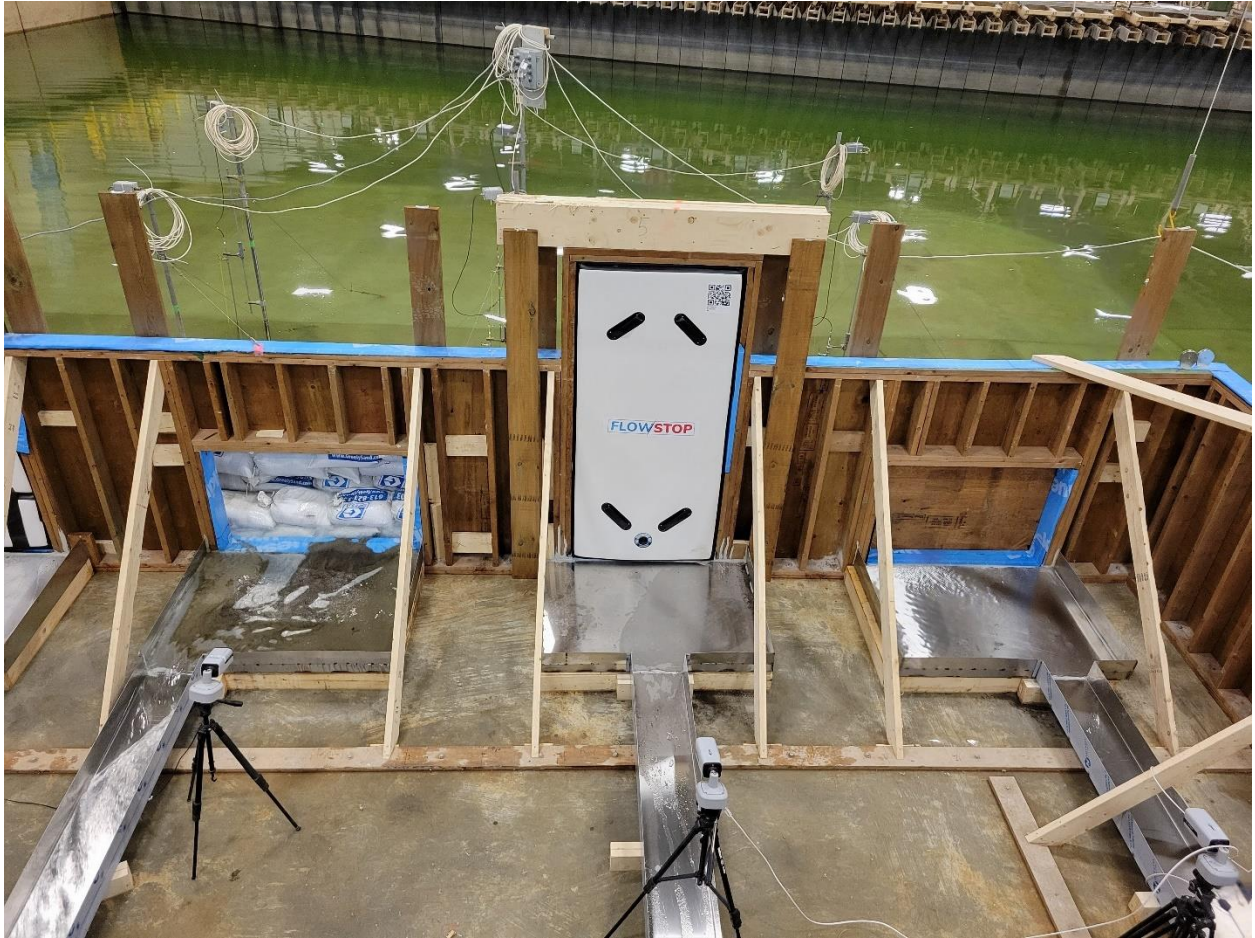
Figure 28. An image of performance testing of flood protection measures, from left to right sandbags, FlowStop full-sized cushion and plywood.

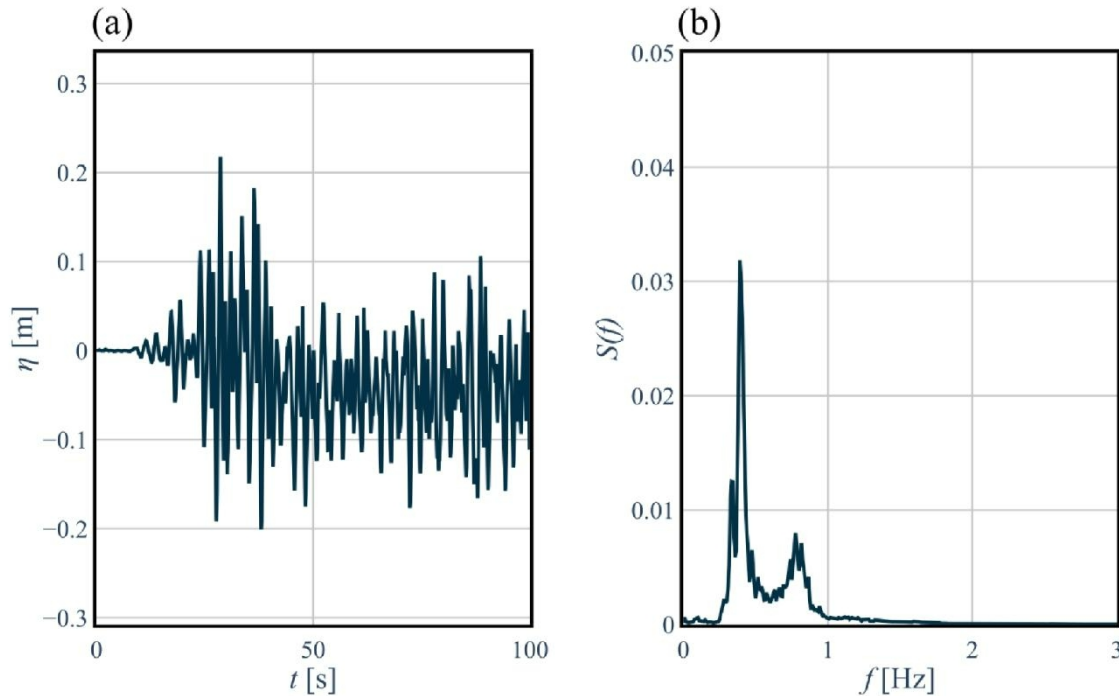
Figure 29. Frequency analysis of wave time series (WP01). (a) Time series of water surface elevation; (b) frequency analysis of water surface elevation.

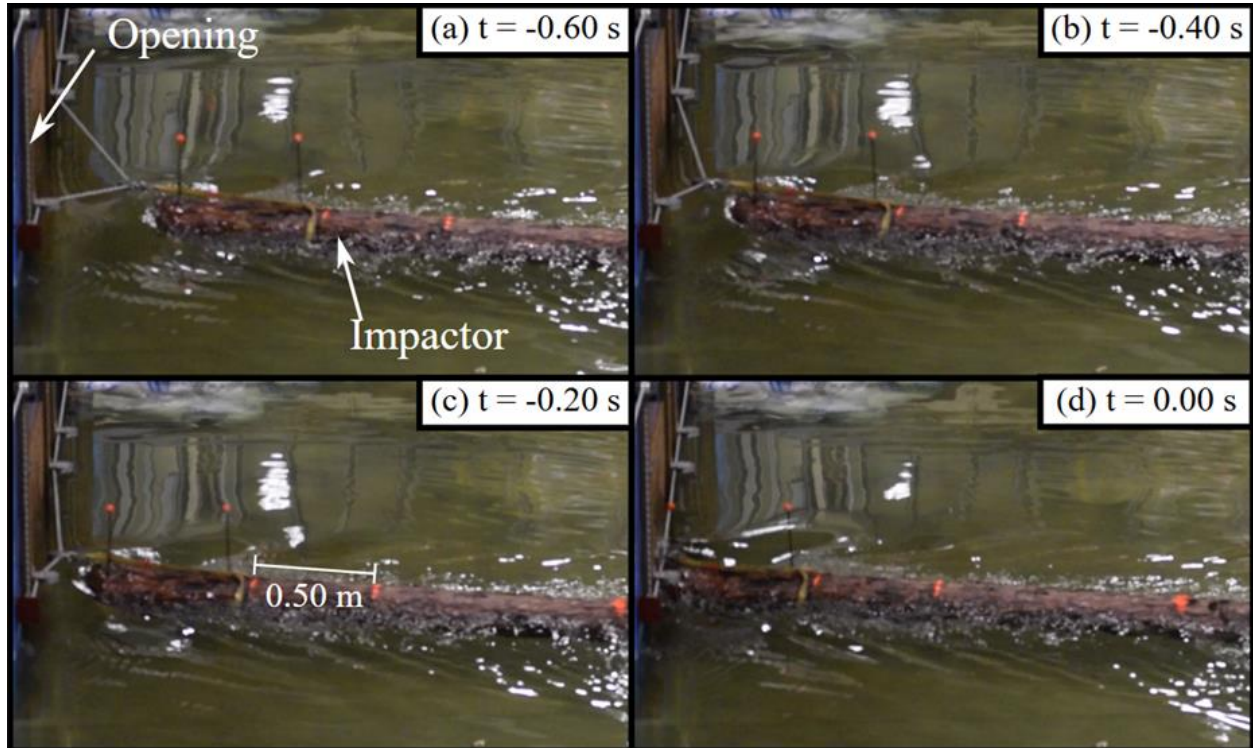
Figure 30. Debris impact testing in Phase 2 in the MWB showing the approach of the debris to a plywood barrier protecting a window opening. The time is provided in reference to the impact time.

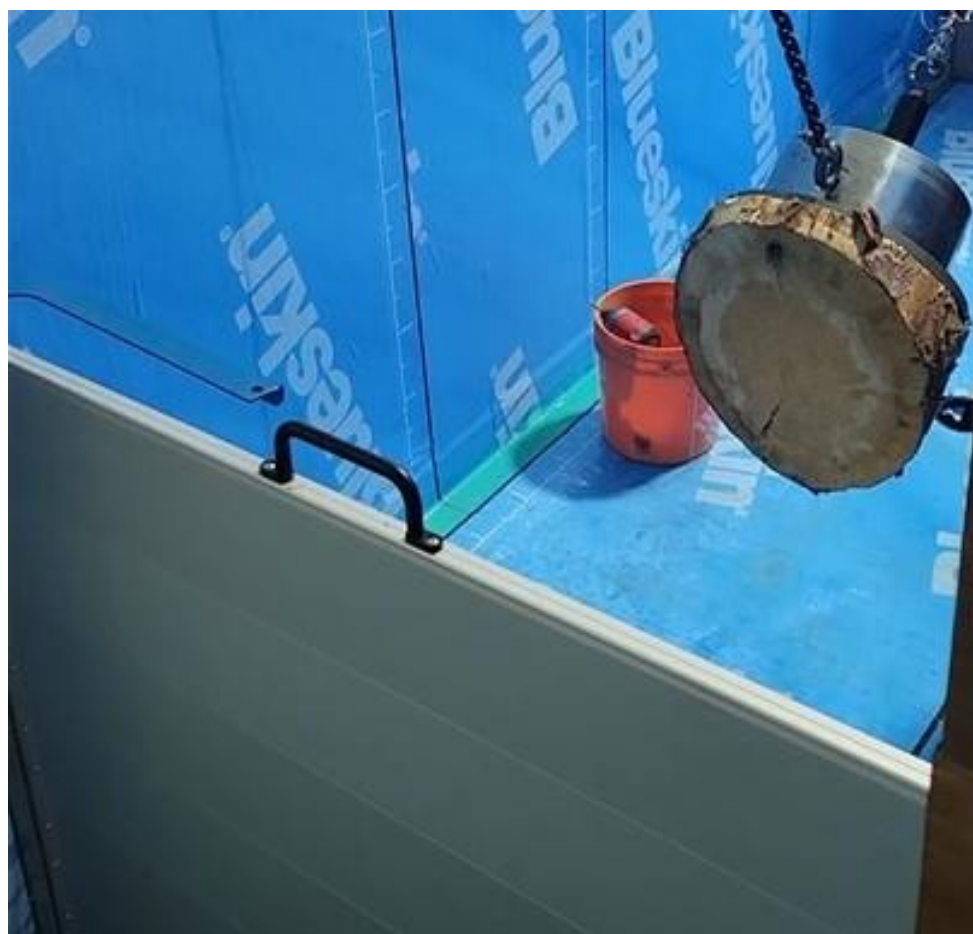
Figure 31. Debris impact testing in Phase 2 in the Ice Tank.

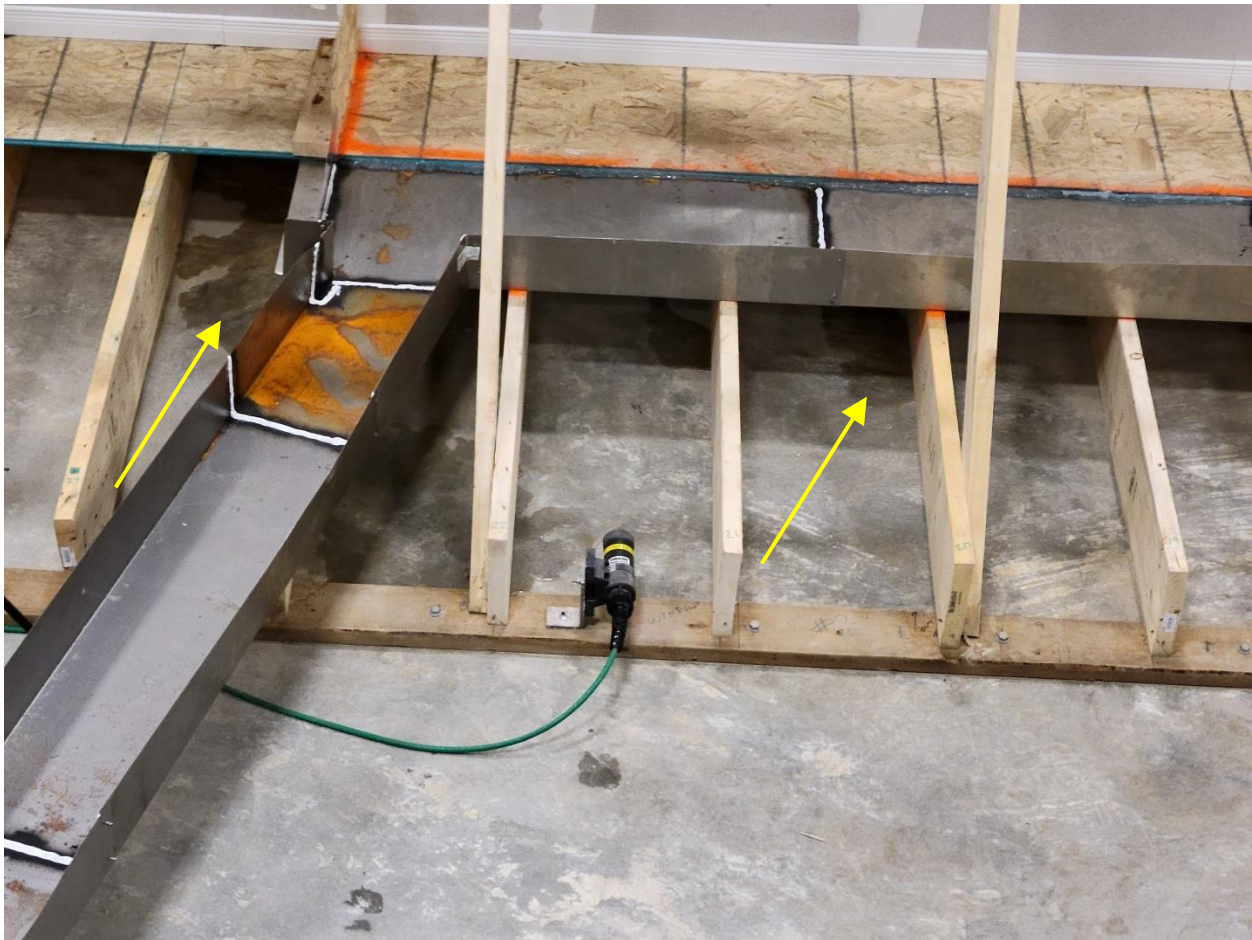
Figure 32. First evidence of leakage observed on top of the concrete pad in Phase 1 testing shortly after exposing the home to rising flood waters.

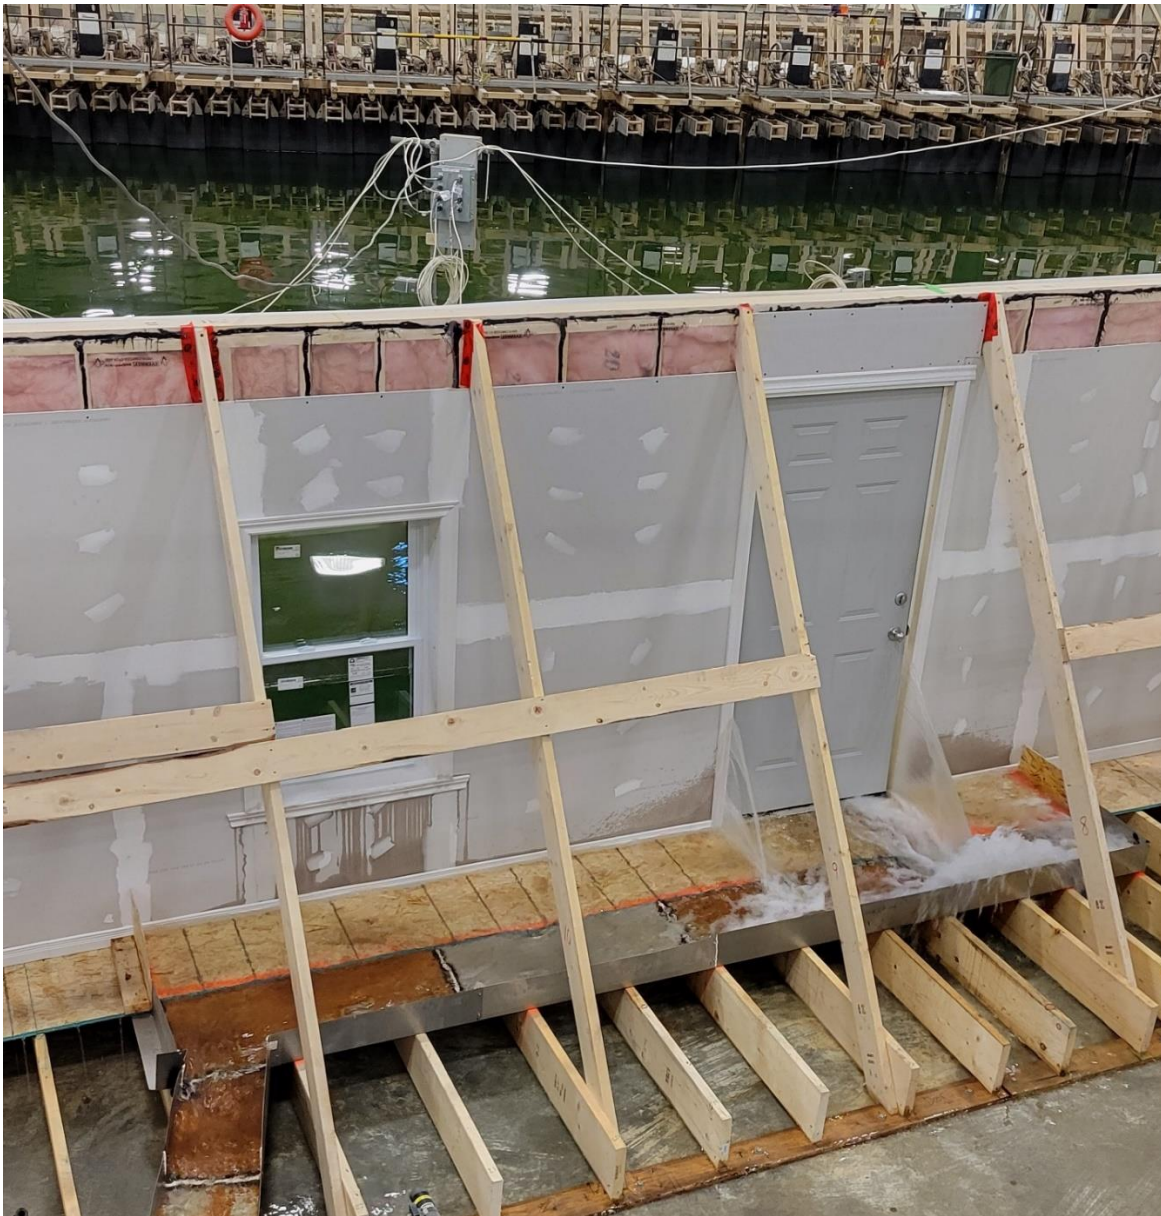
Figure 33. Leakage through the door observed in Phase 1 at maximum water depth.

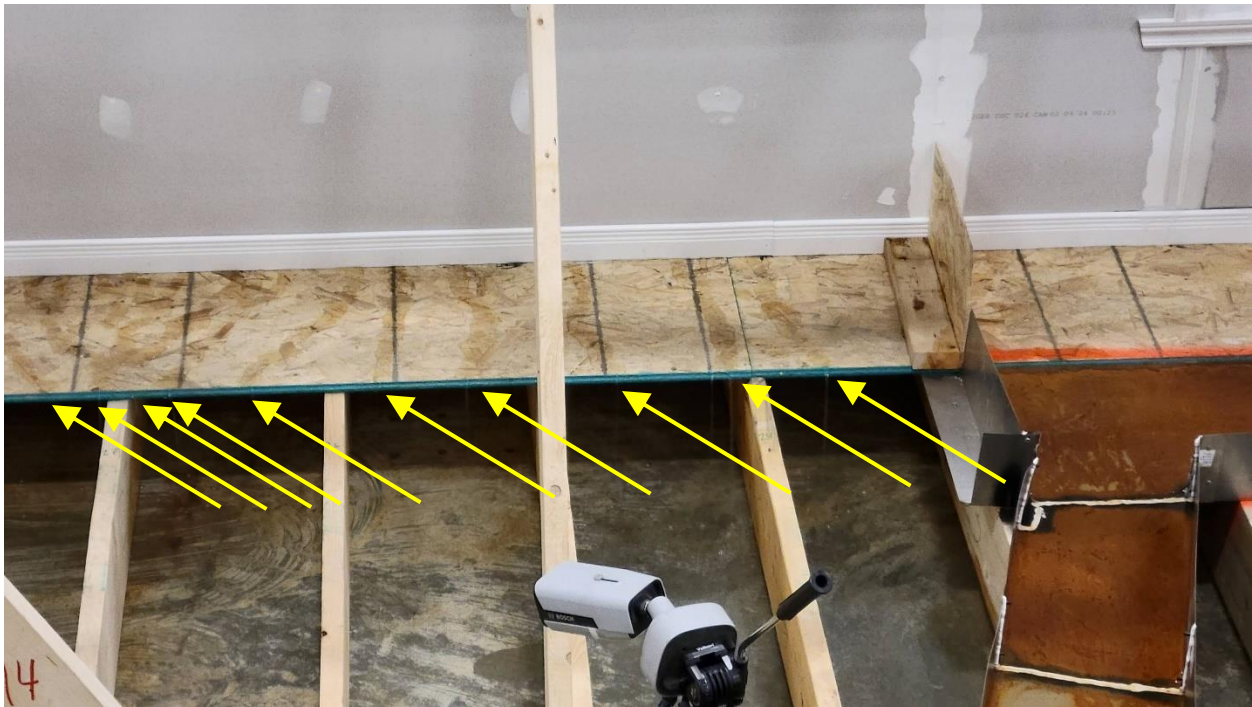
Figure 34. Leakage through the wall cavity in Phase 1. Water trickling off the subfloor identified with yellow arrows.

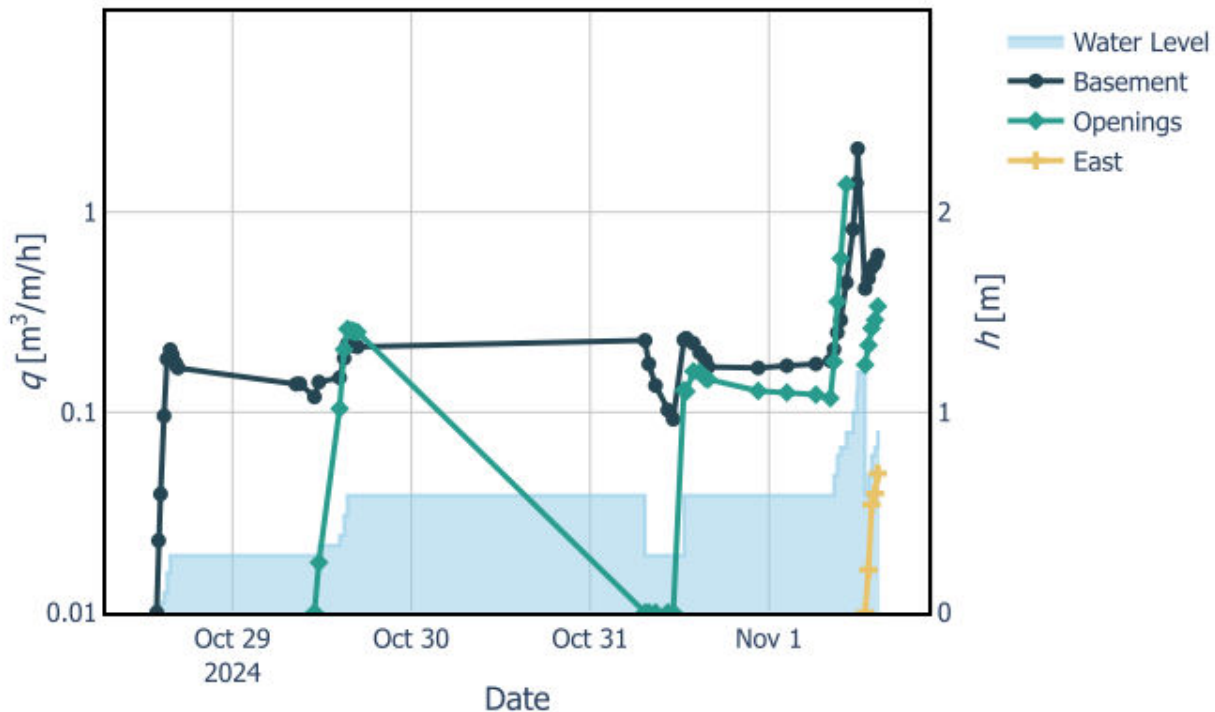
Figure 35. Leakage rate per unit width through the Phase 1 superstructure. The water levels are given in absolute coordinate (referenced to the floor of the raised platform). Time is given in Eastern Standard Time (EST).

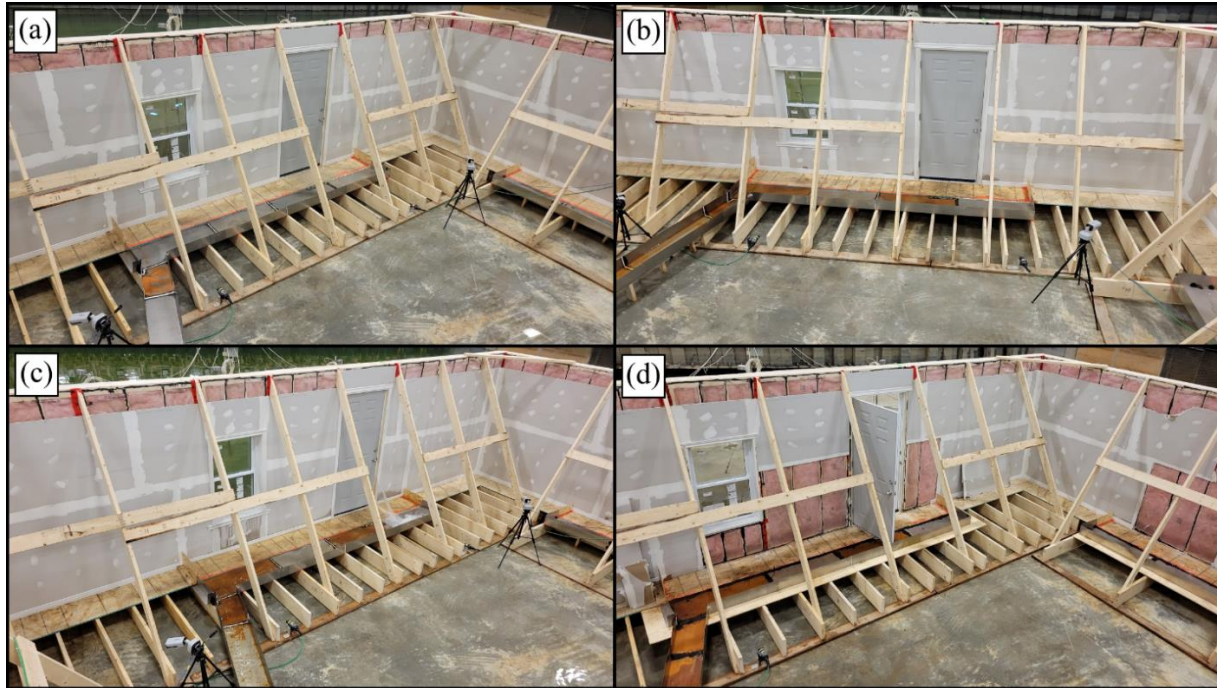
Figure 36. Evolution of water damage to Phase 1 superstructure. (a) Before the start of testing; (b) after the TSA; (c) during TSD; (d) during the deconstruction process. Note – the drywall was removed as part of the deconstruction, not by the flood waters.

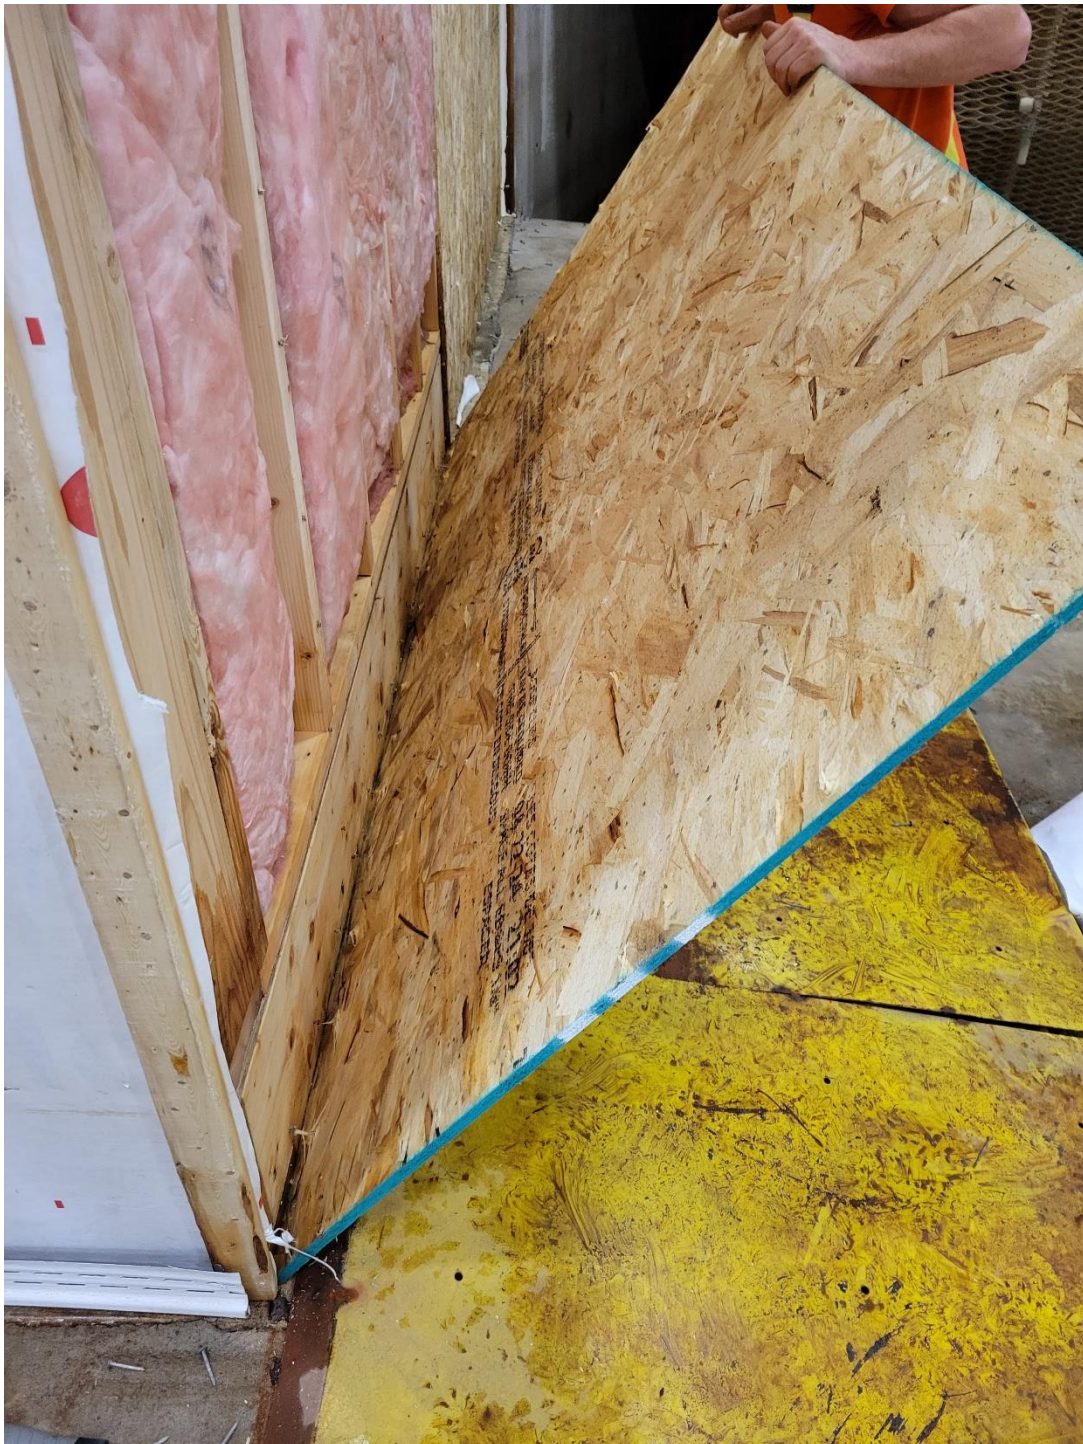
Figure 37. Water damage between the rim joist and the exterior plywood sheathing in Phase 1.

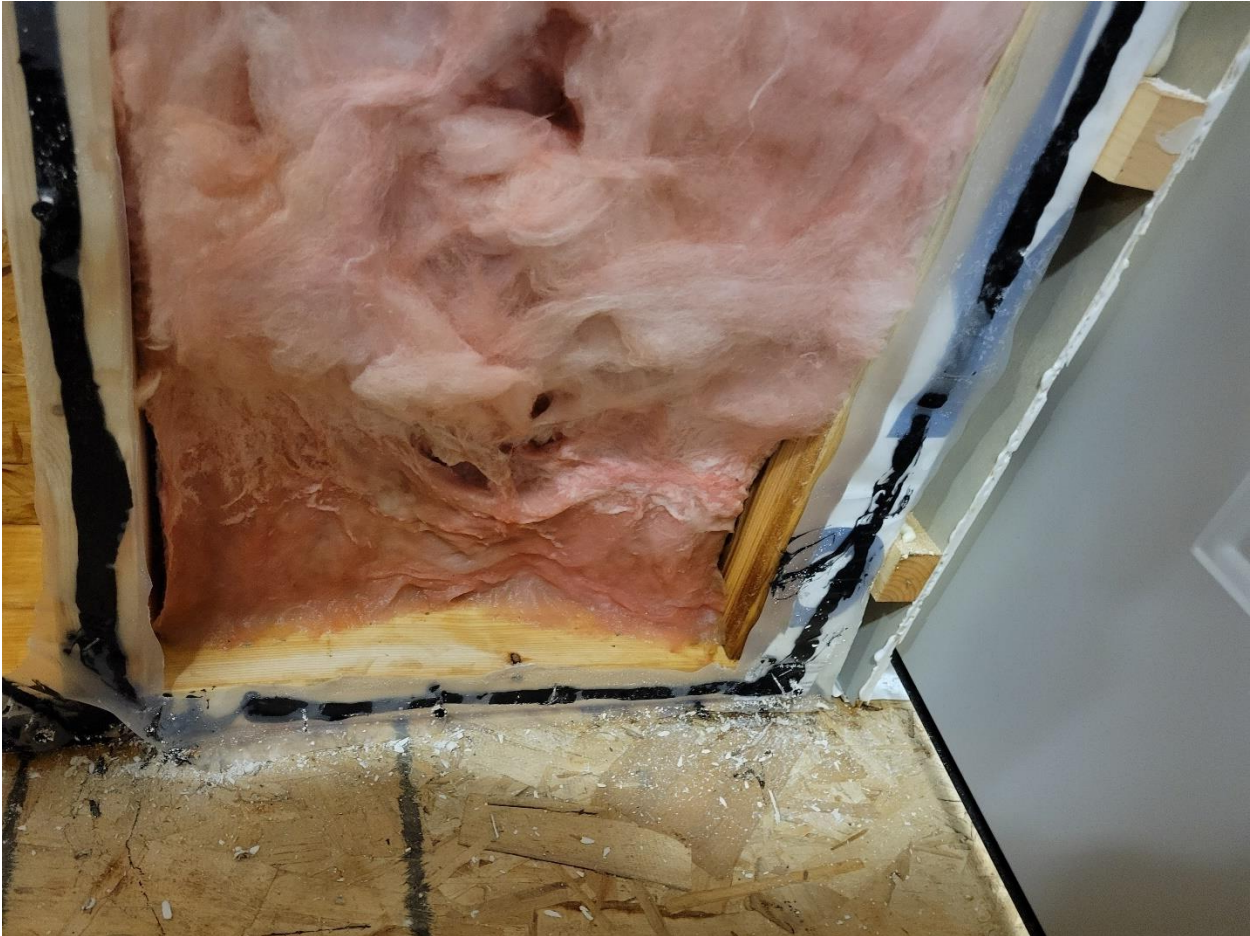
Figure 38. Saturated fiberglass insulation found just beside the door during the deconstruction after Phase 1 testing.

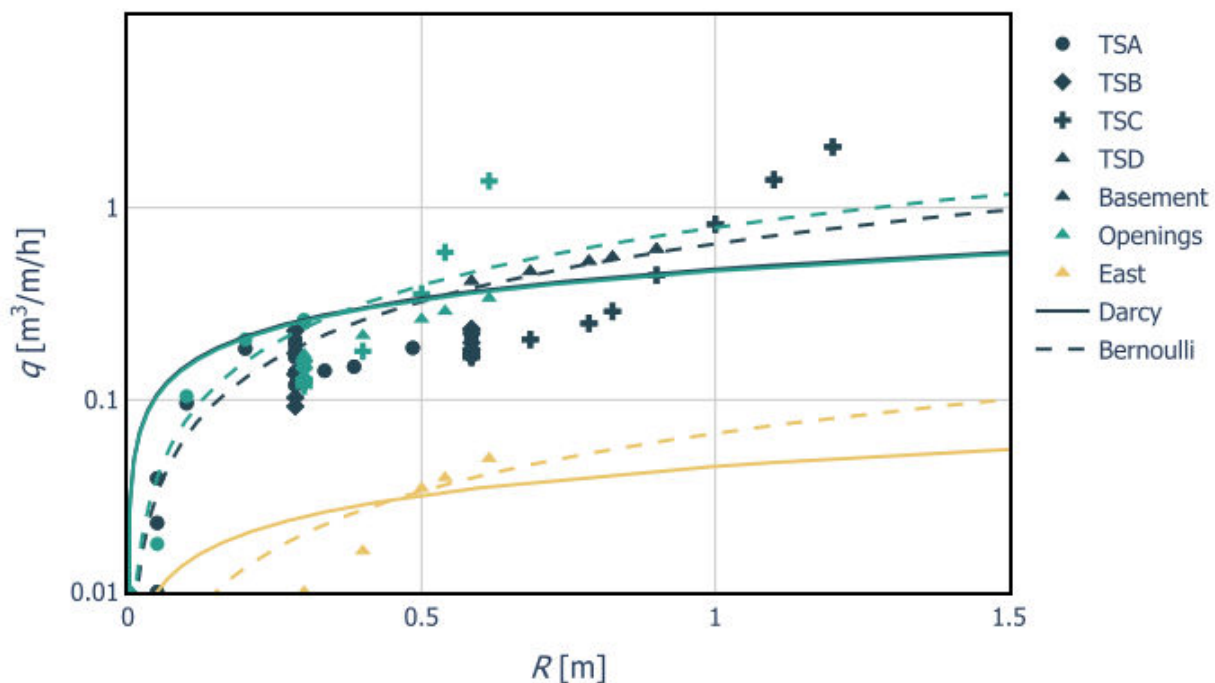
Figure 39. Leakage rate per unit meter versus the relative freeboard through the Phase 1 superstructure. The water level is referenced to the height of the opening: 0.285 m for the opening and east and 0 m for the basement. Lines are the fitted parameters from Table 8.

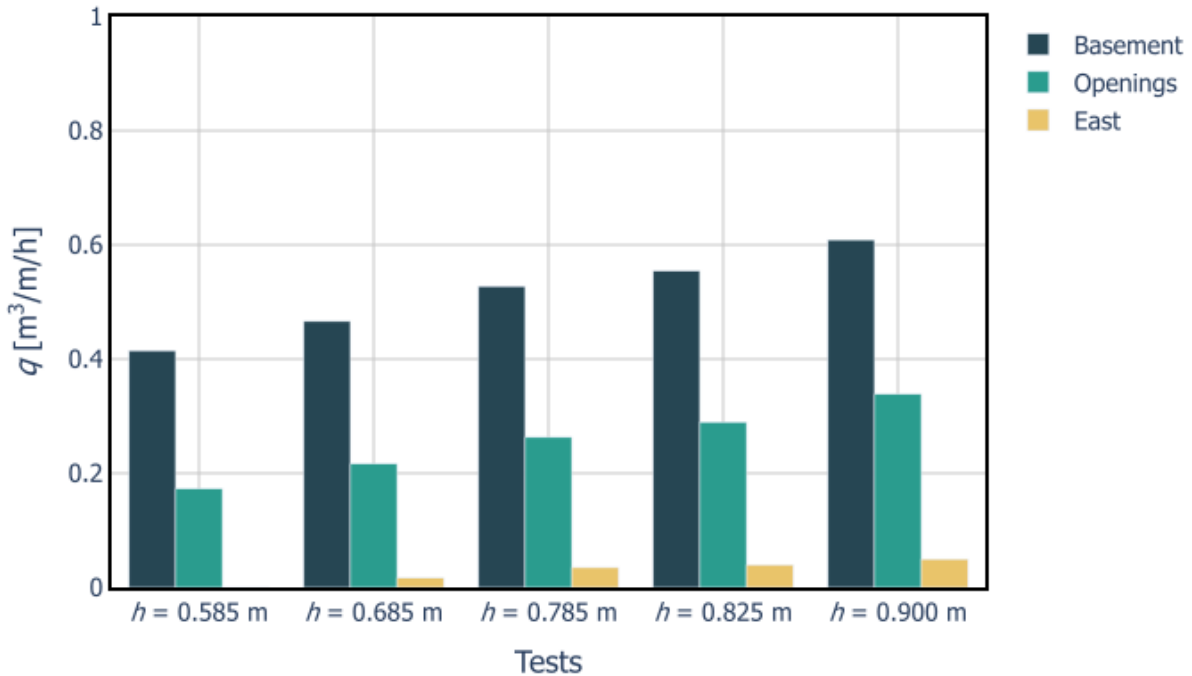
Figure 40. Influence of water depth on leakage rate through Phase 1 structure.

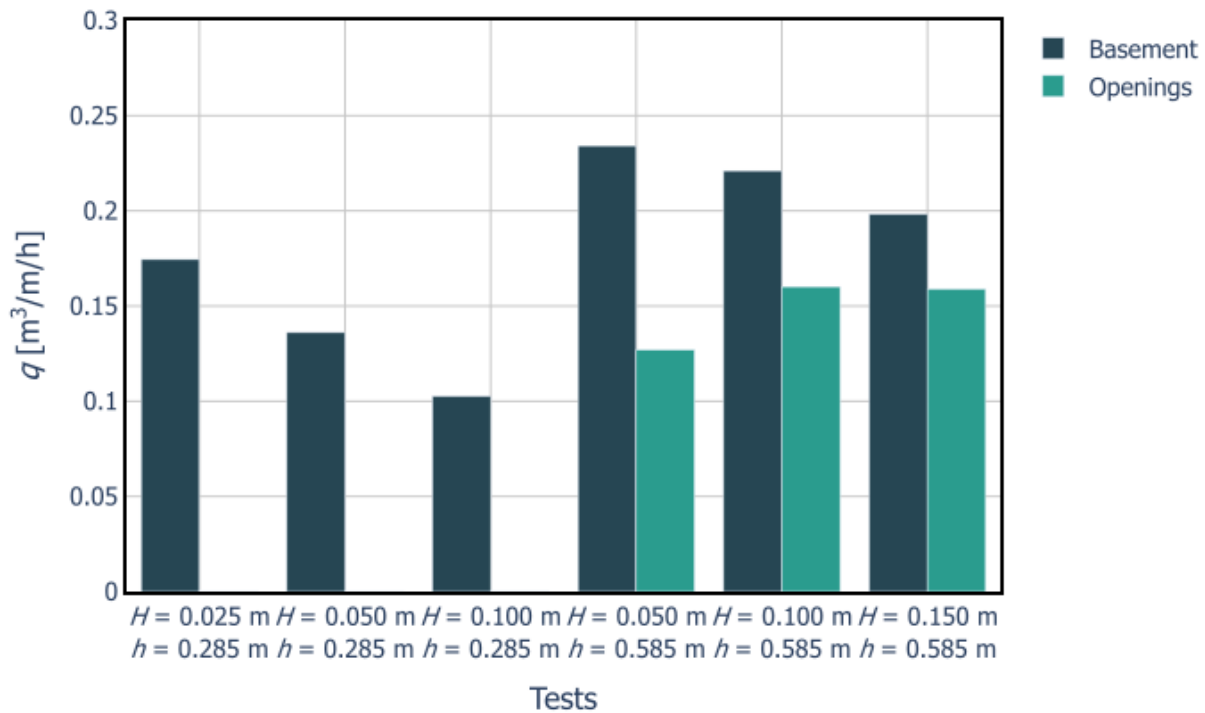
Figure 41. Leakage rates per unit length for Phase 1 superstructure under the influence of various combinations of water depth and zero-moment spectral wave height.

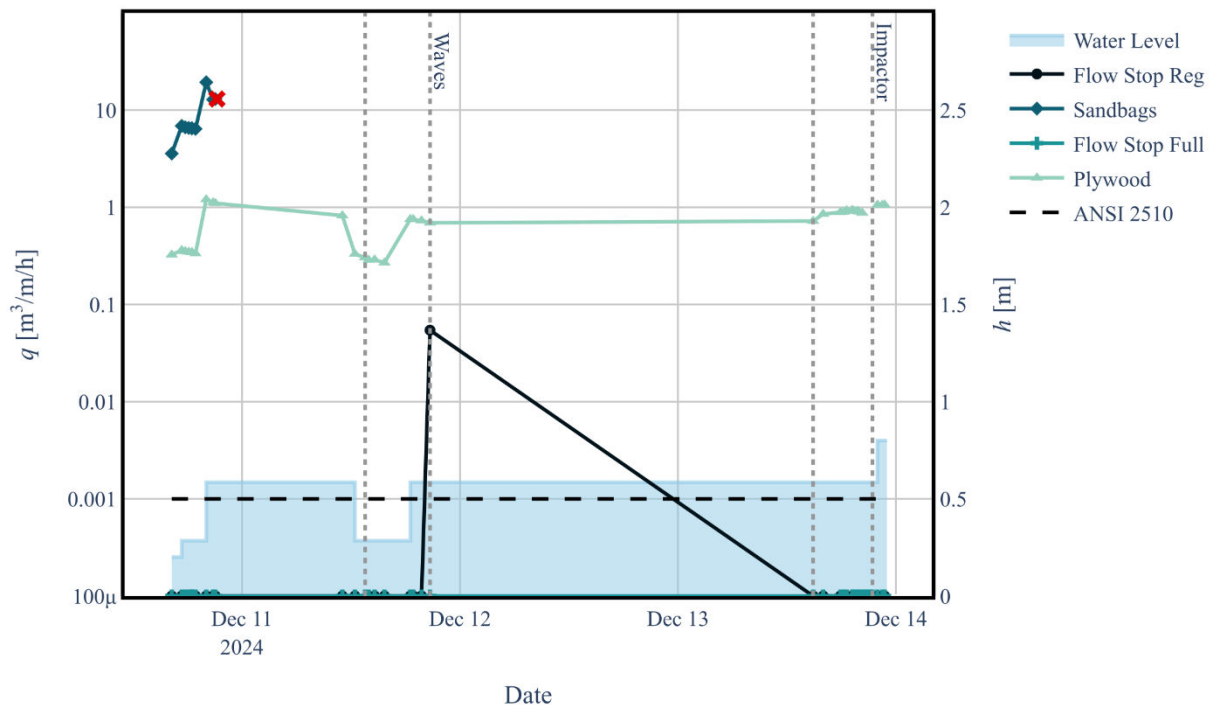
Figure 42. Leakage rate per width of the opening for first run through the experimental protocol in the MWB.

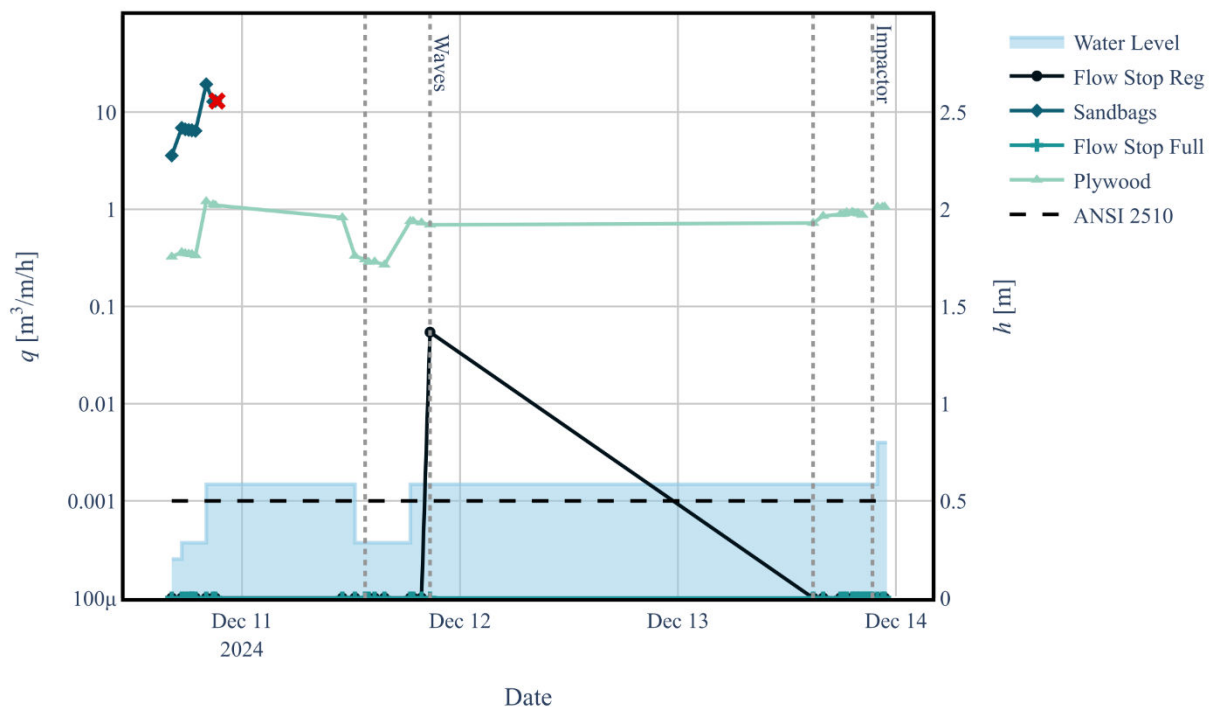
Figure 43. Leakage rate per width of the opening for second test series in the MWB.

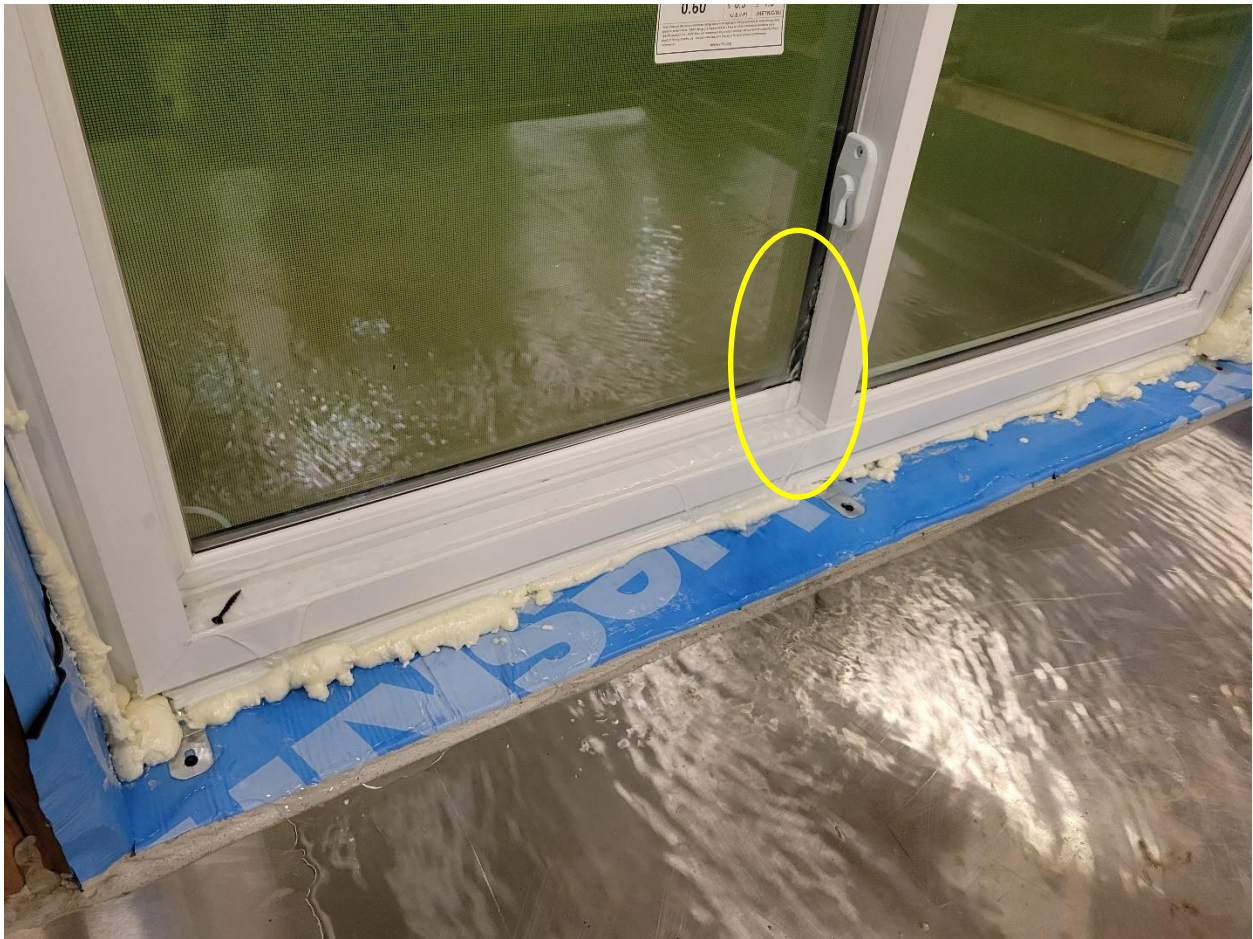
Figure 44. Leakage observed between the two panes of the sliding window in the MWB.

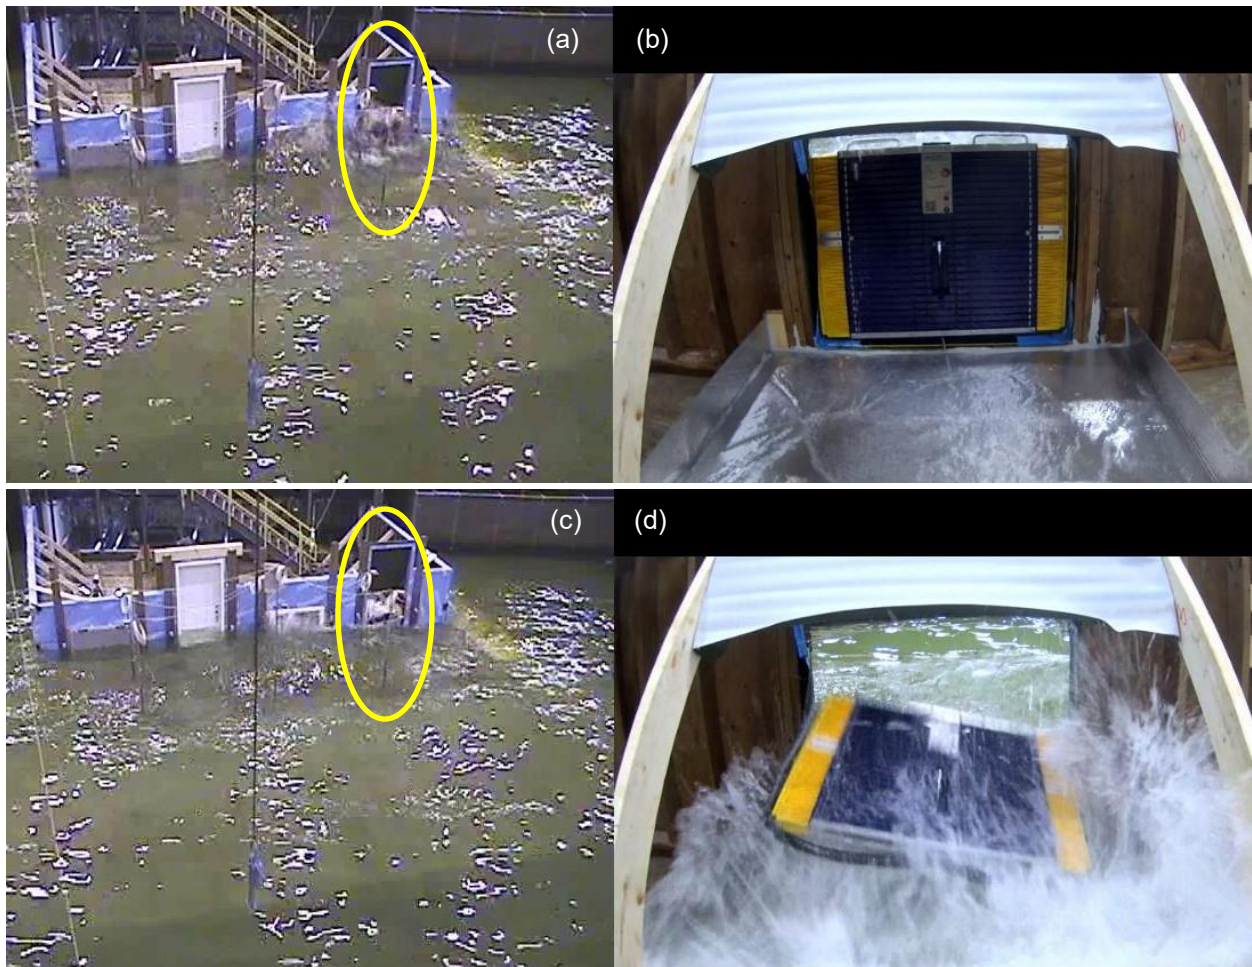
Figure 45. Failure of the DamEasy barrier under wave action. (a) shows the wave crashing against the structure, (b) shows the barrier as the wave crashes, (c) and (d) show the barrier at the moment of failure.
