**Performance of Home of Flood Resiliency and  
Flood Retrofit Measures**

Report No.: NRC-OCRE-2025-TRQ-005

Revision 1.4  
Date: 2025-03-28

Authors: Louis Poirier, Jacob Stolle, and Paul Knox

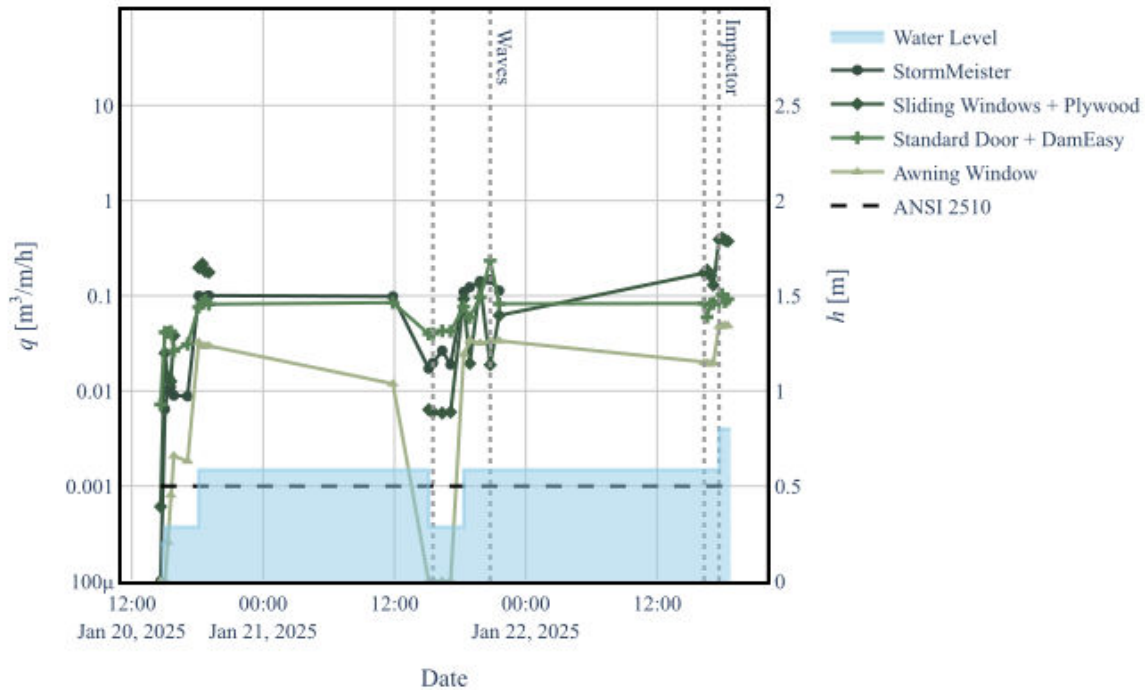
Figure 46. Leakage rate per opening width for the third test series in the MWB.

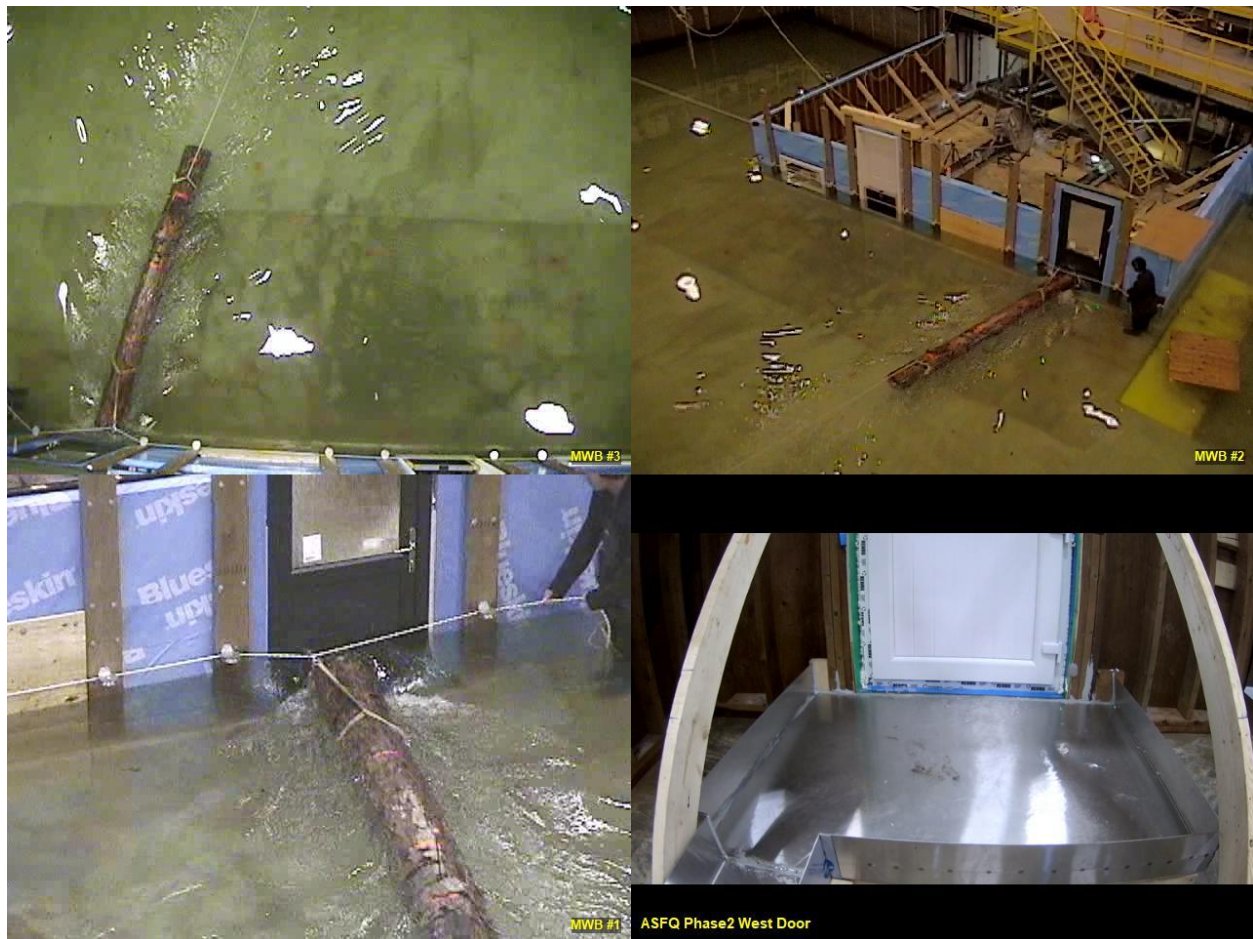
Figure 47. Debris impacting the StormMeister door just prior to failure.

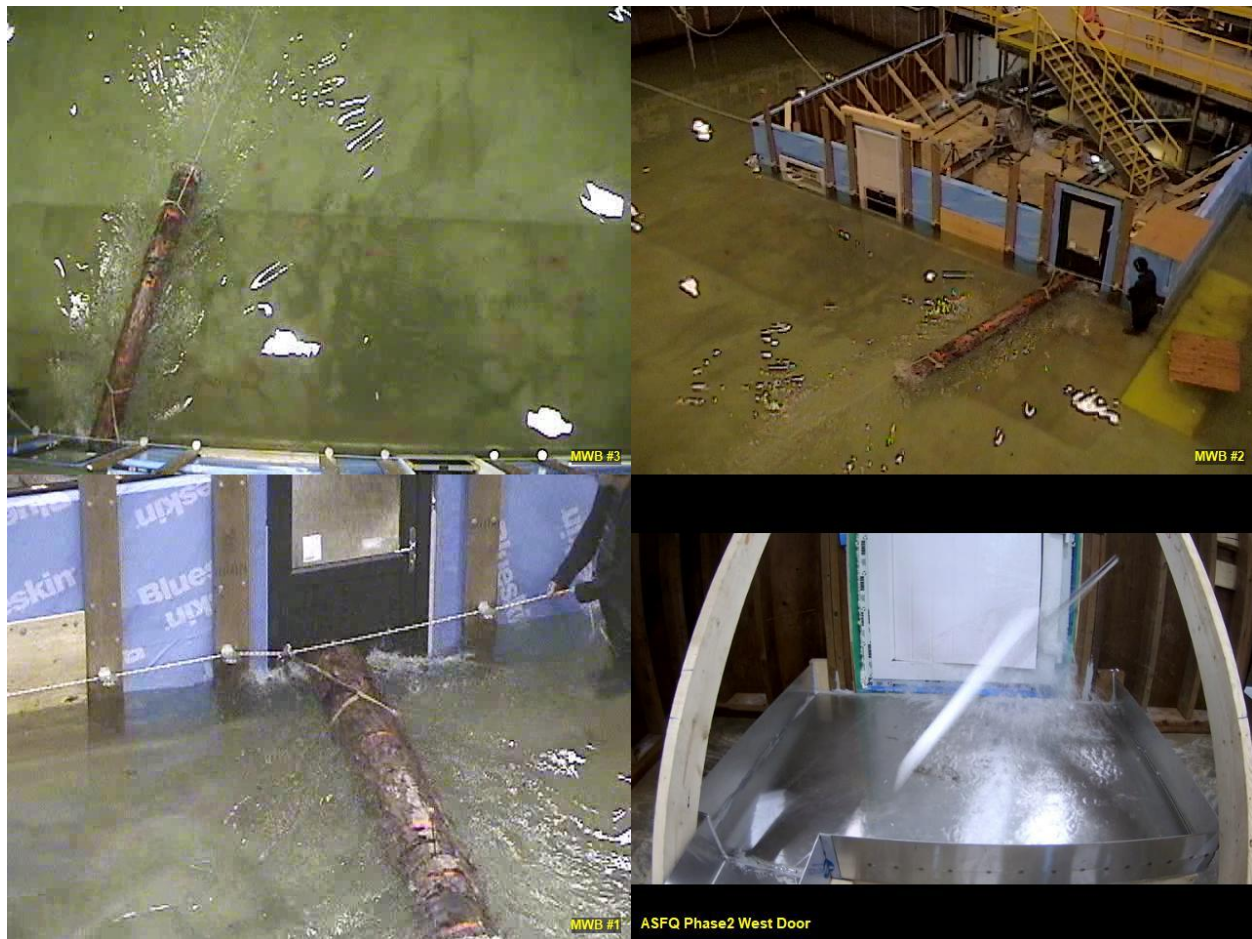
Figure 48. Failure of the StormMeister door under debris impact.

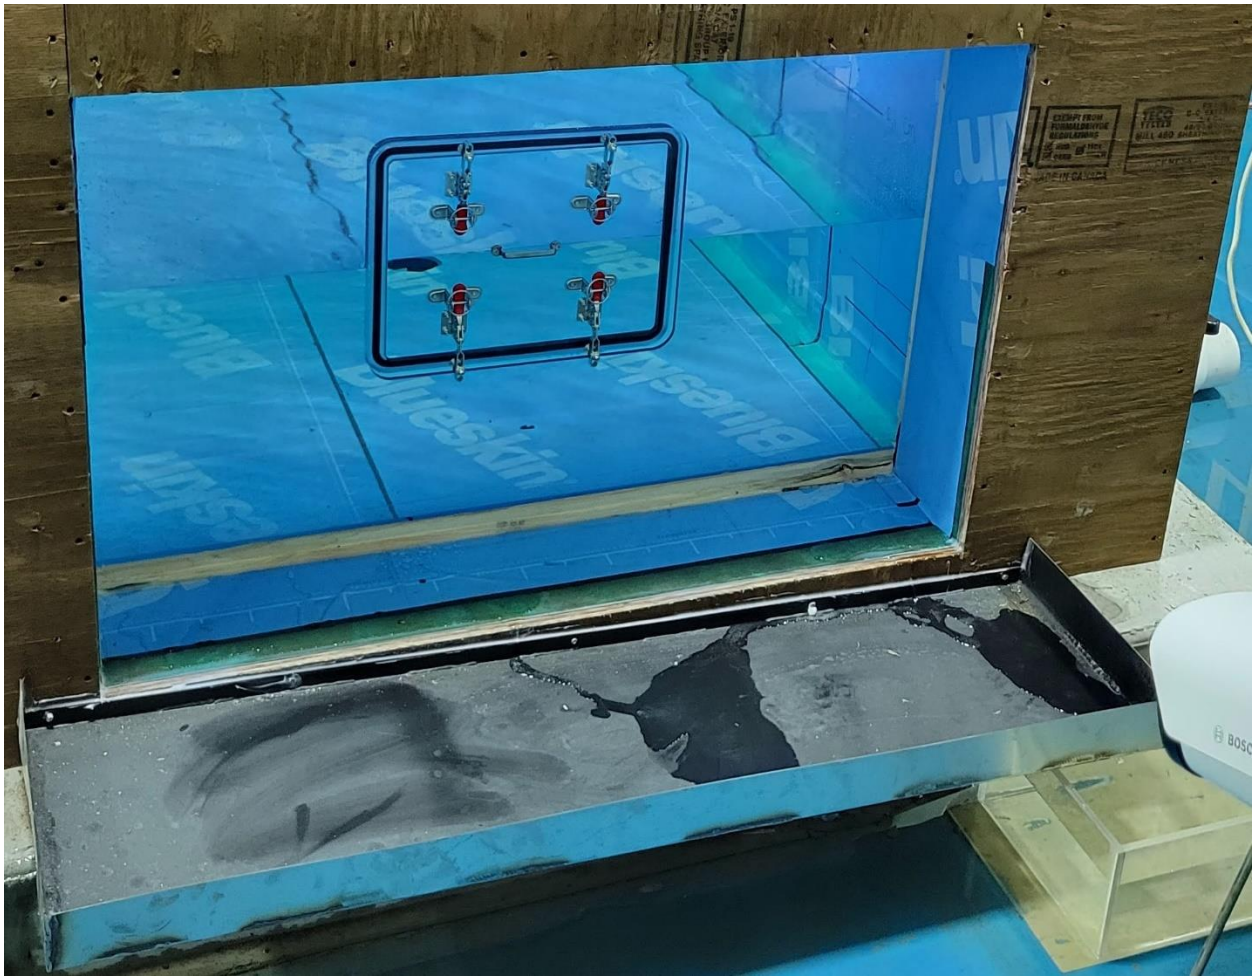
Figure 49. Leakage from the AquaLock window protector, Test Series N and a water level of 0.585 m.

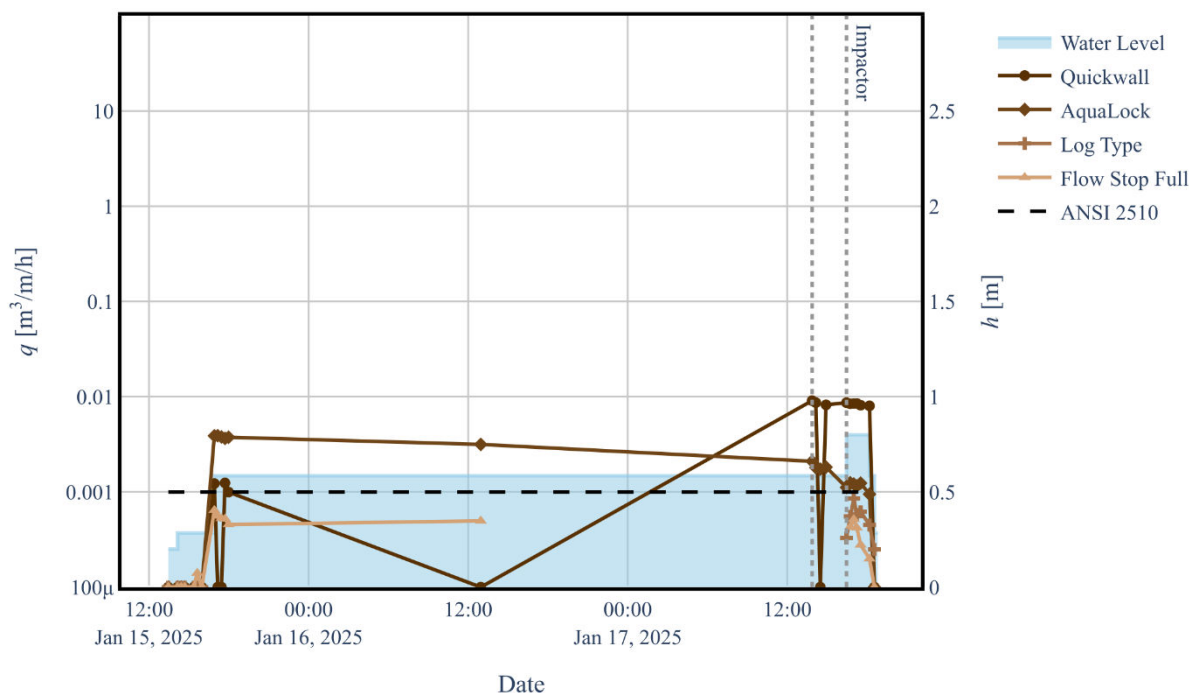
Figure 50. Leakage rate per unit width of the opening for the IT experiments.

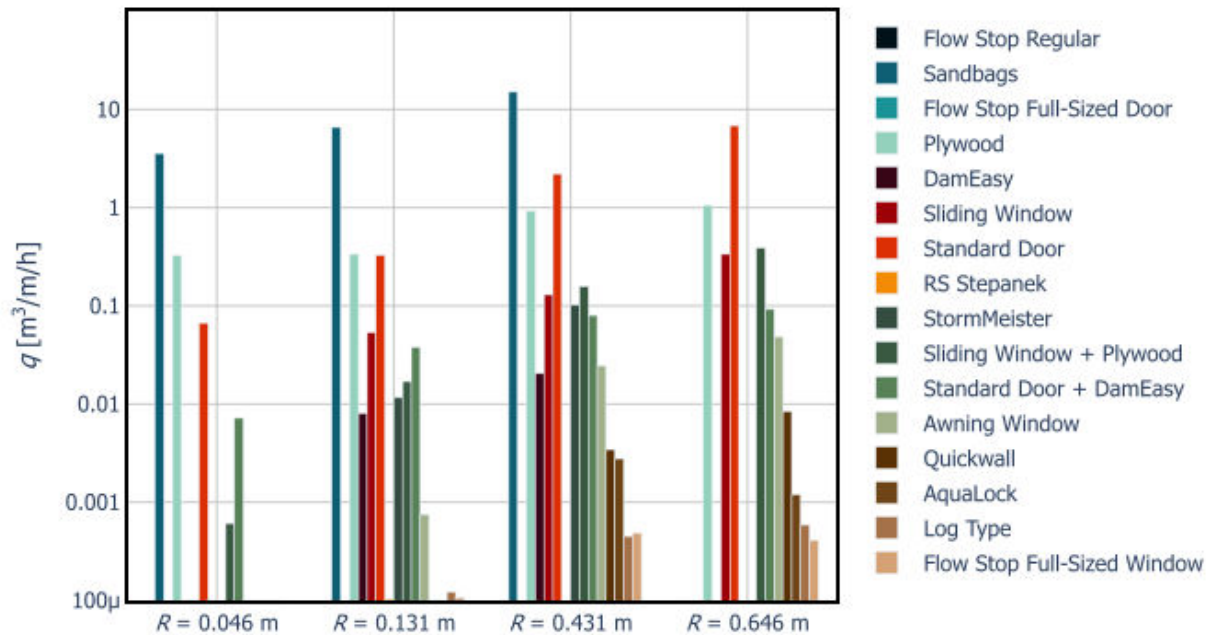
Figure 51. Average leakage rate per unit width as a function of freeboard for each of the barriers tested in Phase 2. The figure combines the tests from the MWB and IT.

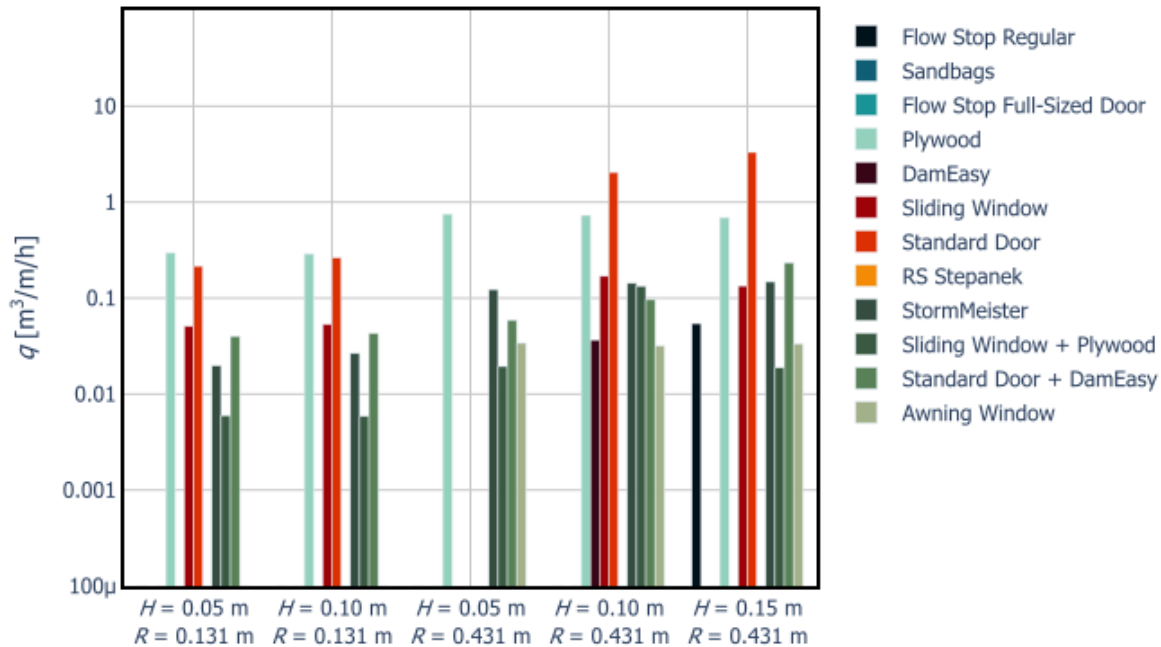
Figure 52. Average leakage rate per unit width for the wave experiments in Phase 2 (MWB only). The figure does not include tests from the IT as no waves were run in that facility.
